01-18-017-18W4M  
GAS/GAS EXCHANGER  
A0190932 84C-3203-02A  
REPORT # A#0190932\_GRADY INSPECTION LTD VE VI UT INSP\_2MAY2022

DATE 5/2/2022  
CLIENT CNRL

<b>LSD</b>	01-18-017-18W4M	<b>Facility</b>	Armada Gas Plant		
<b>DH-LSD</b>		<b>Field</b>	Red Deer District		
<b>Jurisdiction #</b>	A0190932				
<b>Serial #</b>	84C-3203-02A				
<b>Ultrasonic Report #:</b> A#0190932_GRADY INSPECTION LTD VE VI UT INSP_2MAY2022

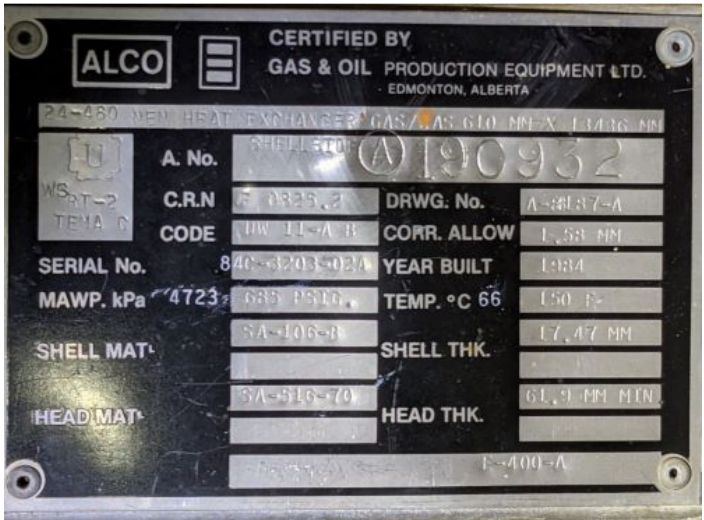
Shell Side Nameplate

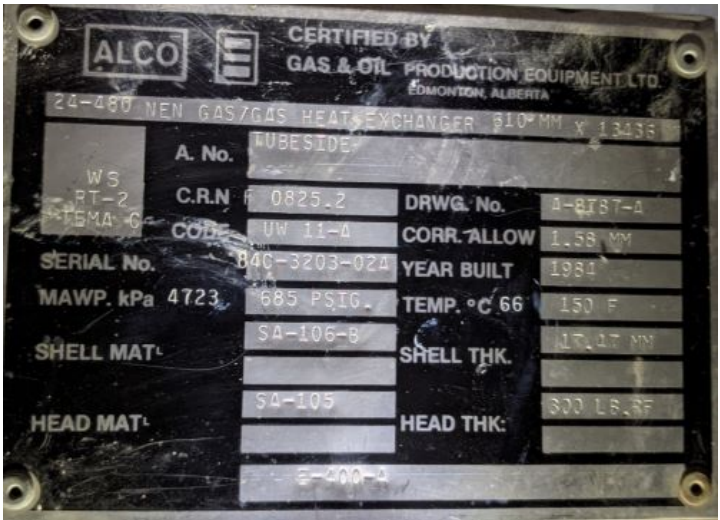
Tube Side Nameplate

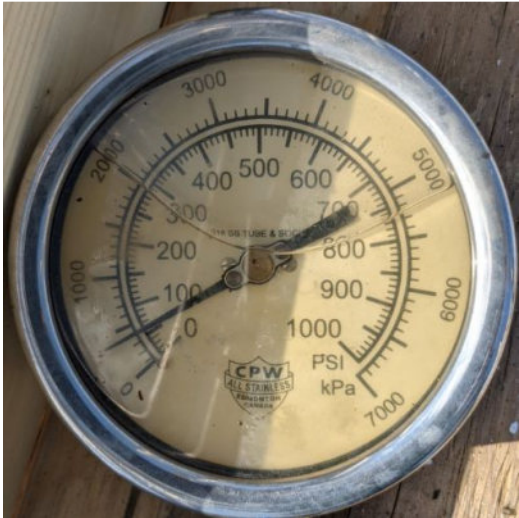
External Inspection Items	G/F/P	Comments
General Condition:	Good	No notable mechanical damage, areas of wear/fretting, distortion, misalignment, or visible weld defects.
External Coating:	Good	Vessel is in good visual condition.
Insulation / Cladding:	Good	Insulation is in good visual condition.
Nozzles, Piping and Connections:	Good	Nozzles and piping in good visual condition
Buried Vessels:	N/A	Above Ground
Ladders, Platforms and Walkways:	Good	Building secure
Foundations and Supports:	Good	Anchor bolts fully engaged
Shell:.	Good	No notable mechanical damage, areas of wear/fretting, distortion, misalignment or visible weld defects.
Saddles / Skirts:	Good	Saddle is in good visual condition. Unable to view attachment to shell
Grounding:	Good	Grounding is achieved through the skid.
Gauges and Instrumentation:	Fair	<div>Shell Gauge ( 0 - 1000 @ )      Temp Gauge ( 0 - 250 @ )</div> <div>Tube Side Pressure gauge is suitable for MAWP Shell Side Pressure Gauge on LTS is not suitable for MAWP Tube side and Shell Side Temperature gauges are in good condition</div>

Pressure Gauge

<b>Fit For Service:</b>	Fit For Service.
<b>Inspection Summary:</b>	Vessel is in good visual condition.
<b>Recommendations:</b>	Confirm Shell Side PG is suitable for PSV set pressure or replace with suitable gauge. Inspect PSV after installation to confirm suitability

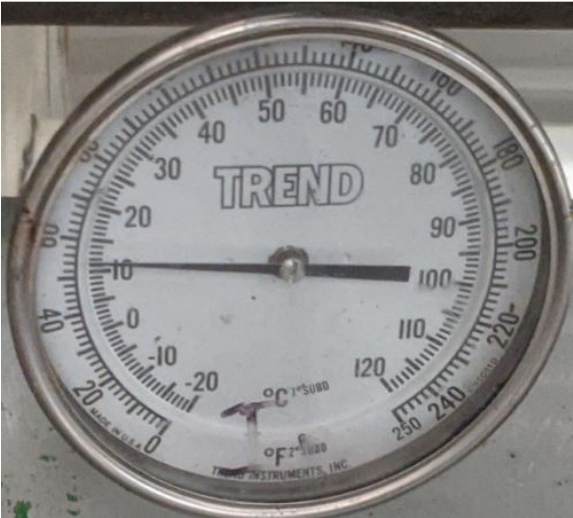
Temperature Gauge

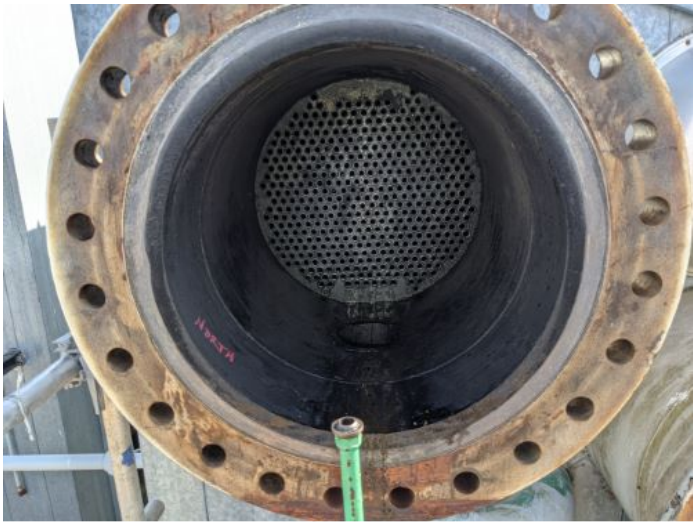
North Overview

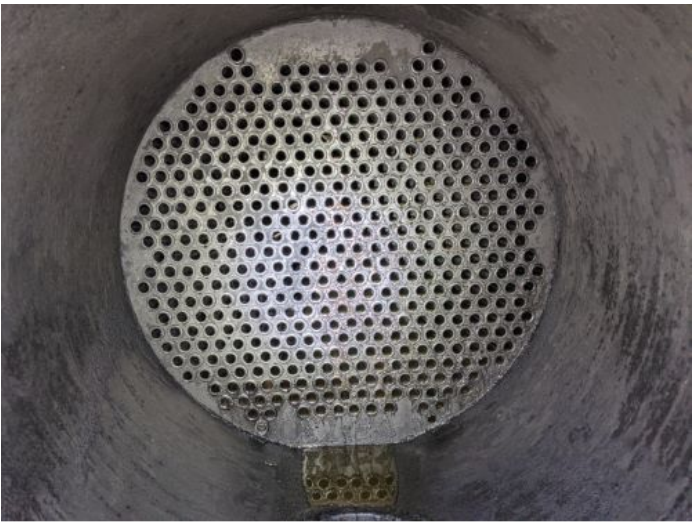
North Tubesheet

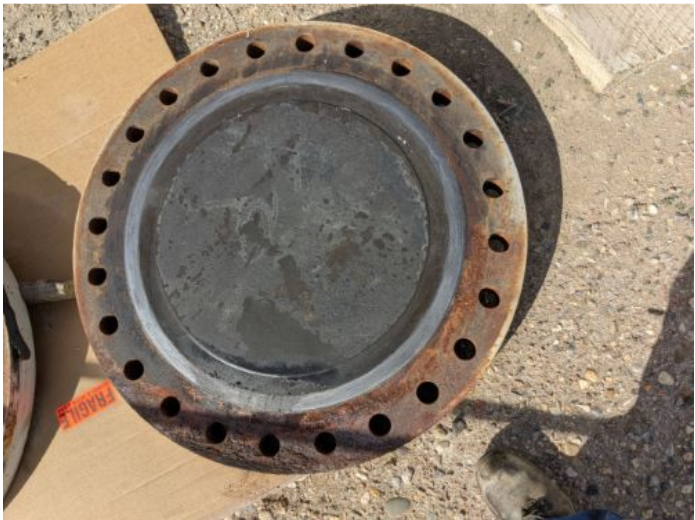
North manway cover

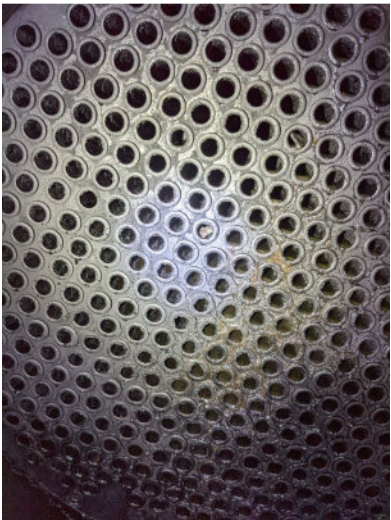
Bundle / Tubes:		Good	Minor visible solid build up in a few tubes. Will not affect process.
Nozzles / Manways:		Good	No notable corrosion, erosion, mechanical damage or weld defects observed.
Welds:		Good	No weld defects observed.
Vortex Breakers, Drains, etc:		N/A	
Internal Coating:	N/A	<input checked="" type="checkbox"/> NotCoated

Close Up of tubes

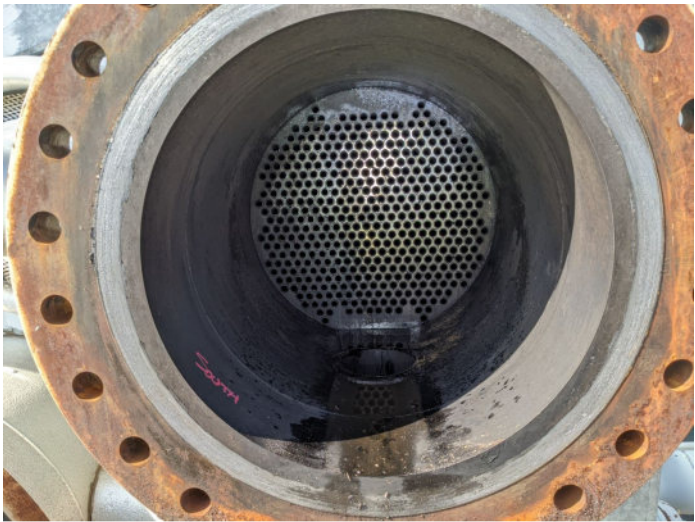
South Overview

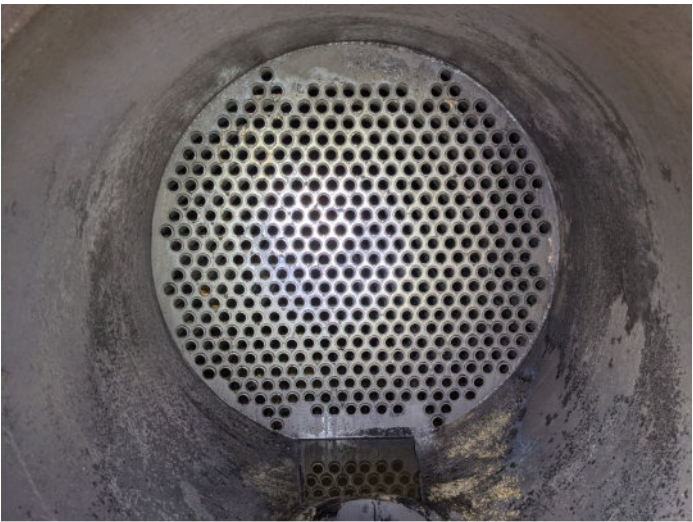
South Tubesheet

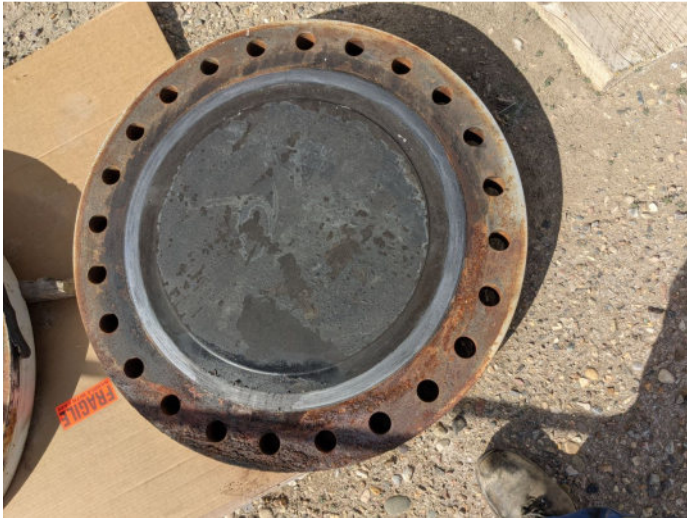
South Manway Cover

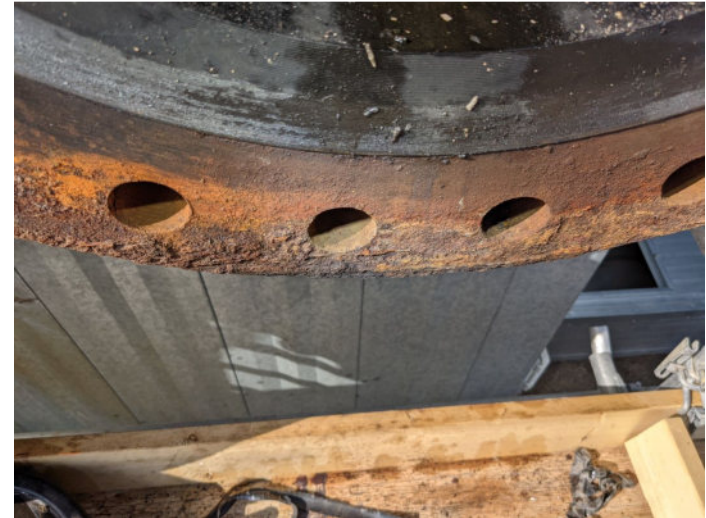
<b>Inspection Summary:</b> Overview of Inspection Findings	Internal inspection conducted on channel sections only. No notable corrosion, erosion, mechanical damage or weld defects observed. Minor corrosion observed within the gasket sealing surface of the South blind flange. Discussed with maintenance personnel and it was determined that seal integrity would not be diminished. Minor visible solid build up in a few tubes. Will not affect process.
------------------------------------------------------------	--------------------------------------------------------------------------------------------------------------------------------------------------------------------------------------------------------------------------------------------------------------------------------------------------------------------------------------------------------------------------------------------------------------

Sealing Surface Corrosion

**Non-Conformances and Corrective Actions:****Preparatory Work Required for Next Inspection:****Recommendations for Next Inspection:** Inspect the South blind flange gasket seal for leakage once the vessel is back in service
