November 26, 2018  
File: 113678238

**Reference: Brazeau County – Secondary Emergency Egress Route**

Stantec Consulting Ltd. has been requested by Coast Pacific Oil and Gas Management Corporation to provide a high-level opinion on the feasibility of utilizing an existing, semi-graded access road, as a secondary point of egress for residents located on Township Road (Twp Rd) 500, east of Rocky Rapids and Range Road (Rge Rd) 71 and south of Twp Rd 501A. This secondary point of egress would be considered “as needed” in times of an emergency evacuation of residents in the area, should Twp Rd 500 be otherwise blocked or impassible. There are approximately 15 affected properties within this area being considered.

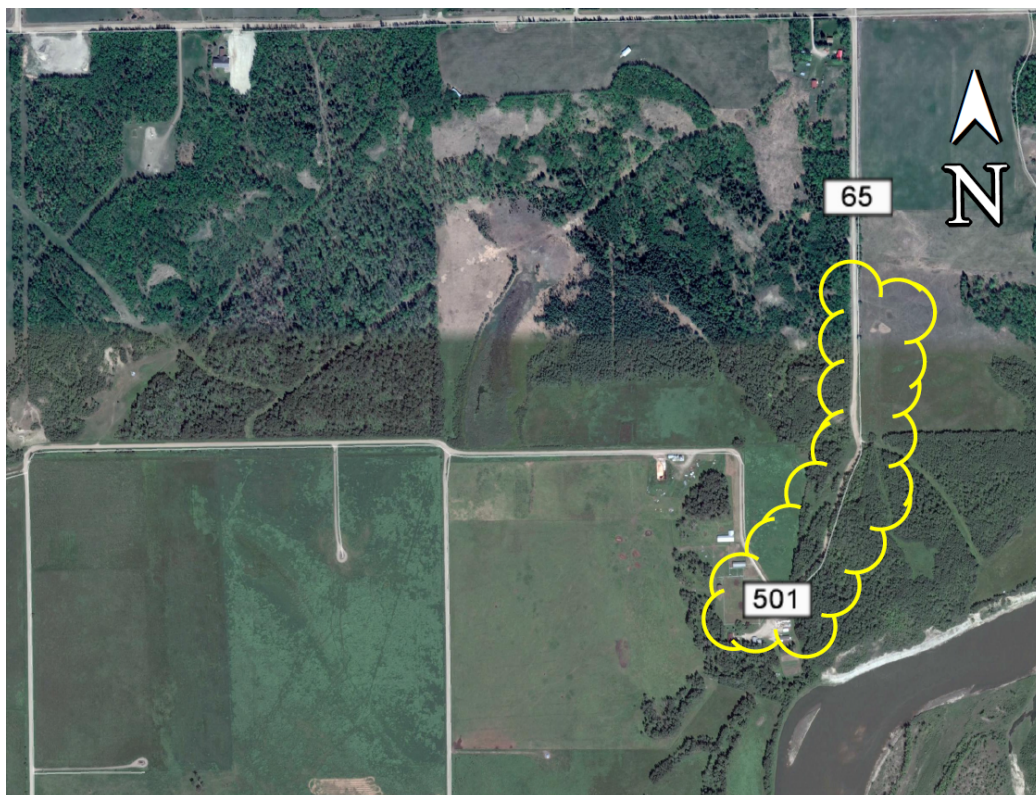
**Figure 2 – Project Site Review Area**

The existing private access is located on the east end of Twp Rd 501A and connects north to Rge Rd 65. A site visit was conducted on November 20, 2018, mid-afternoon, to observe the condition and characteristics of the road and determine whether the road could be safely traversed by a vehicle. The roadway has been carved out along the edge of a forested embankment, sloping downward both north to south and east to west. The road was snow covered at the time of review, however travelled frequently enough by vehicles to present clear, packed tracks for a vehicle in a single direction. It is assumed that the access road has a graveled top surface. During the review, two other vehicles were witnessed using the roadway; one travelling north, while the other travelling south.

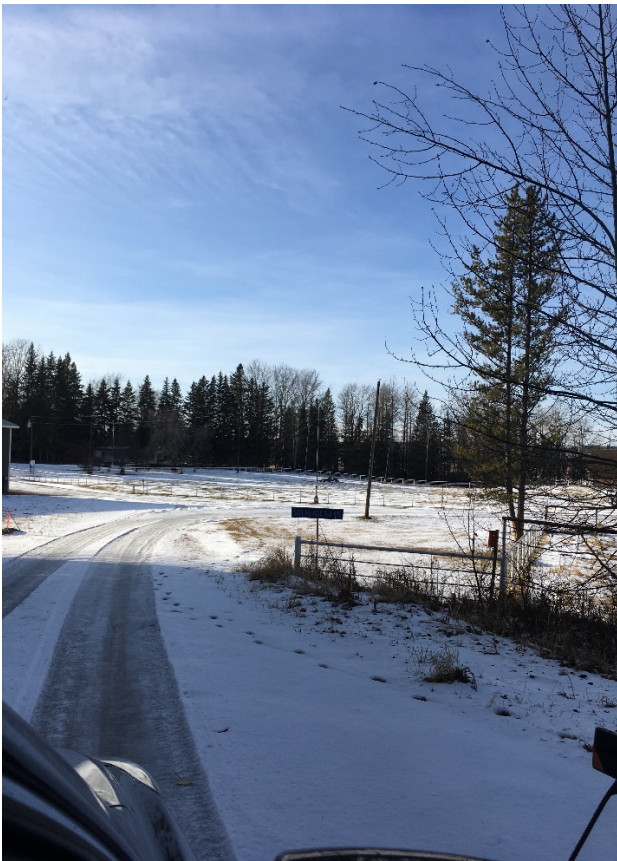
**Figure 3 – Access Road Entrance – Looking West**

The private access roadway has a wide 90 degree turn at the base of the hill, and slight curvature ascending the hill. The road width varies slightly, but consistently appears greater than 4m in surface width. The roadway slopes from east to west with a shallow ditch on the east side of the access road, however no formal drainage conveyance system was apparent, and surface water appears to shed across the roadway in locations that are generally flatter. Approximately three quarters of the way up the hill, a partial wash out of the west half of the roadway exists that has been fenced off with traffic barricades and warning signs. This section of roadway is still accessible as vehicles hug the east side of the road to pass the area safely.

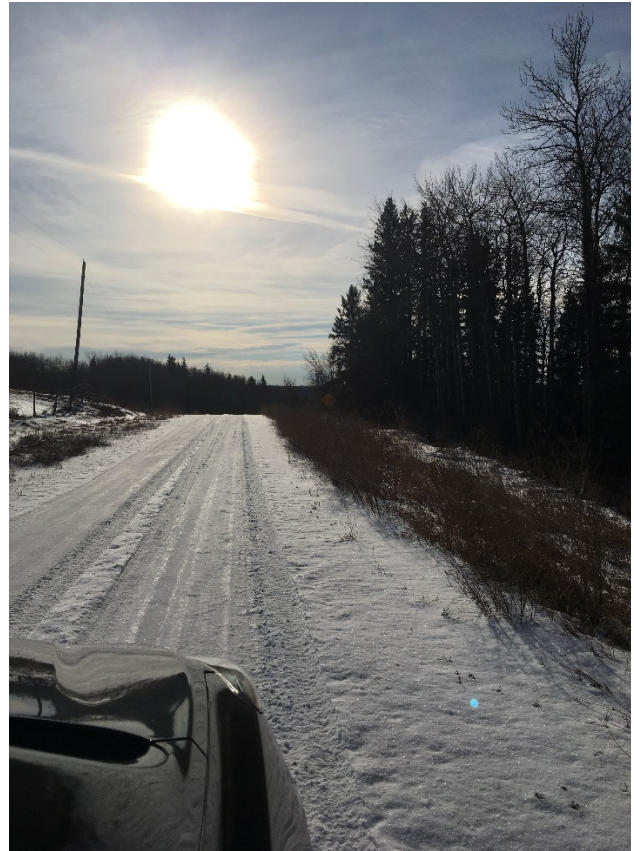
**Figure 6 – Top of Escarpment – Looking South**

The elevation of the roadway increases from south to north as it climbs the embankment, with an elevation change of approximately 36m over a length of 485m (referencing Google Earth topography). The roadway varies in grade with both steep and flatter sections. The site review was conducted using a mid-sized SUV and did not experience any difficulties climbing or descending the access road under the packed snow and icy conditions. It should be noted that travelling along Rge Rd 70, approximately 500m north of Twp Rd 500, the existing roadway has vertical characteristics similar to that of the access road but accommodating two-way traffic.
