PROCESS FUEL GAS SCRUBBER

84C-3202-01AC65695

REPORT # 84C-3202-01A_GRADY INSPECTION LTD VE UT INSP_1APR2022

DISTRICT	AB - OIL & NATURAL GAS				SHELL		TUBE	
FACILITY	Armada Gas Plant			MAWT	100			F
A#		YR	1984	MAWP	150			psi
SERIAL #	84C-3202-01A			PSV	150			psi
CRN	C4262.213			PSV CRN	0G8841.5C			
EQUIP#				SERVICED	6/7/2017			
STATUS	IN SERVICE			UNIT	Refridge			
MANUFACTURER	ALCO GAS & OIL PRODUCTION EQUIPMENT LTD.							
DH LSD				L	2.5 Ft	OD	.9	Ft
REPAD	UNIQUE ID C65695

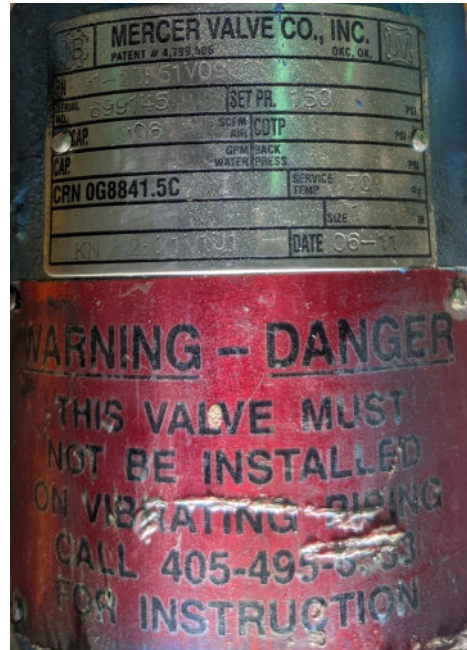
PSV Data
LSD

UVL ID#: 38071B		S N: 699145	
Man: MERCER		Model: 91-23F51V09U1	
Set Press: 150 PSI		Capacity: 908 SCFM	
Cold Diff:		Back Press: PSI	
Size: 1" MNPT		X 1.5" FNPT	
A#:			
Vessel SN:			
WO#: 613111		CRN: 0G8841.5C	
PO#:		PO Line#	
REVISION 3 / 7082014 QF-01

Not Fit For Service.

Check Valve on PSV discharge line PSV located in Ajax / K101 compressor.

VE Inspection:
Remove Check valve from PSV discharge line.
Install drain piping and drain vessel periodically
