01-18-017-18W4M
GLYCOL SOCK FILTER
293-2FLC65694
REPORT # 293-2FL_GRADY INSPECTION LTD VE UT INSP_1APR2022

DATE 4/1/2022
CLIENT CNRL

PRESSURE EQUIPMENT										AB-506 INTERVAL													
DISTRICT		AB - OIL & NATURAL GAS				SHELL		TUBE		Upstream pressure vessels not													
FACILITY		Armada Gas Plant				MAWT		257		F		GRADE				YEARS		REG					
A#		YR		1983		MAWP		150				psi		3		Equip		PSV		UT		REG	
SERIAL #		293-2FL				PSV		150				psi											
CRN						PSV CRN		0G8841.5C															
EQUIP#						SERVICED		6/7/2017															
STATUS		IN SERVICE				UNIT		Refridge				X										X	
MANUFACTURER		FELCO IND.												INSPECTION RESULT:									
DH LSD						L		2.7		Ft		OD		.72		Ft		NCR-OPERATIONS					
REPAD		2				UNIQUE ID		C65694												NCR-REGULATORY/ADMIN		X	
																				ACTION ITEM RAISED			
																				REPAIR REQUIRED			
																				SUITABLE FOR SERVICE		X	
																				RECOMMENDATIONS:			
																				VE Inspection: Confirm CRN. Ensure CRN is stamped on vessel nameplate.

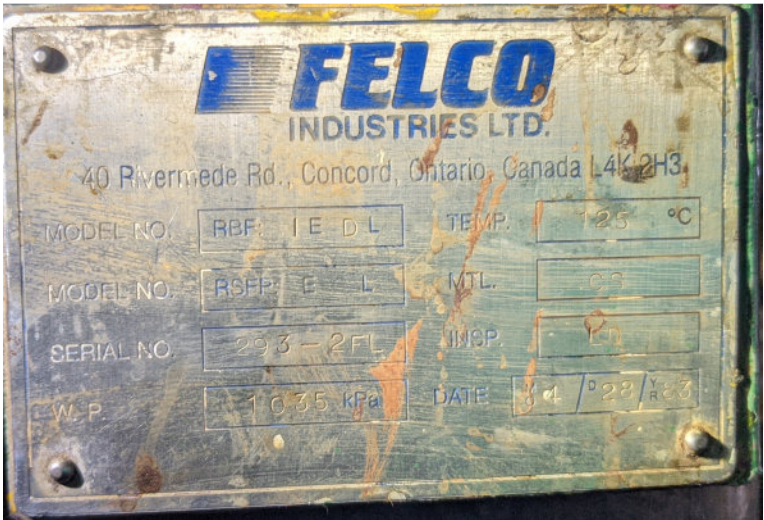
Gauges and Instrumentation:	Fair	<div>Shell Gauge (0 - 60 @ 5)</div> <div>Temp Gauge (- @)</div> <div>Gauge is clear, colorless and correct for the MAWP.</div>
Pressure Protection:	Good	The PSV Set Pressure (150 psi) is suitable for the MAWP (150. psi)
NDE Summary:	Good	No corrosion was found with the ultrasonic inspection.
Manway Davits/Quick Closure:	N/A	No Manway
Nameplate:	Poor	Nameplate is legible and readily accessible and securely affixed No CRN visible.

Fit For Service:	Fit For Service.
Inspection Summary:	NCR. No CRN stamped on vessel nameplate
Recommendations:	Confirm CRN. Ensure CRN is stamped on vessel nameplate.

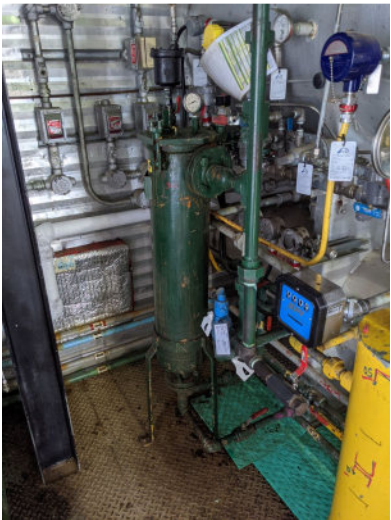
Overview

External Inspection Items	G/F/P	Comments
General Condition:	Good	No notable mechanical damage, areas of wear/fretting, distortion, misalignment, or visible weld defects.
External Coating:	Good	Vessel is in good visual condition. Vessel is painted. Vessel is indoors.
Insulation / Cladding:	N/A	Non insulated vessel
Nozzles, Piping and Connections:	Good	Number of nozzles repaded: 0 Number of nozzles without repad: 2 Nozzles and piping in good visual condition
Buried Vessels:	N/A	Above Ground
Ladders, Platforms and Walkways:	N/A	No attached ladder or platform
Foundations and Supports:	Good	Anchor bolts fully engaged Concrete pilings are intact with no visible deficiencies Building is secure
Shell:.	Good	No notable mechanical damage, areas of wear/fretting, distortion, misalignment or visible weld defects.
Saddles / Skirts:	Good	Saddle is in good visual condition and secure.
Grounding:	Good	Ground Wire is secure Grounded through piping system
