01-18-017-18W4M
3RD STG COOLER
808006.4BC65691
REPORT # 808006.4B_GRADY INSPECTION LTD VE UT INSP_31MAR2022

GRADY
INSPECTION LTD

RESULTS OF INSPECTION:

VE Inspection:
Fit For Service. Vessel is in good visual condition.
PSV service seal is broken
UT Inspection:
No corrosion was found with the ultrasonic inspection.

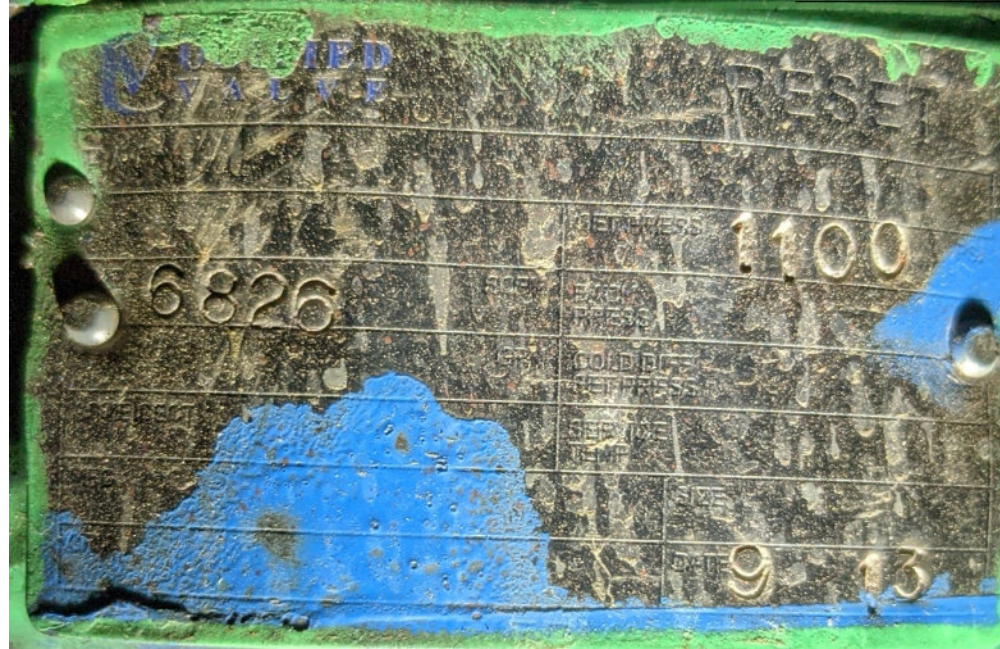
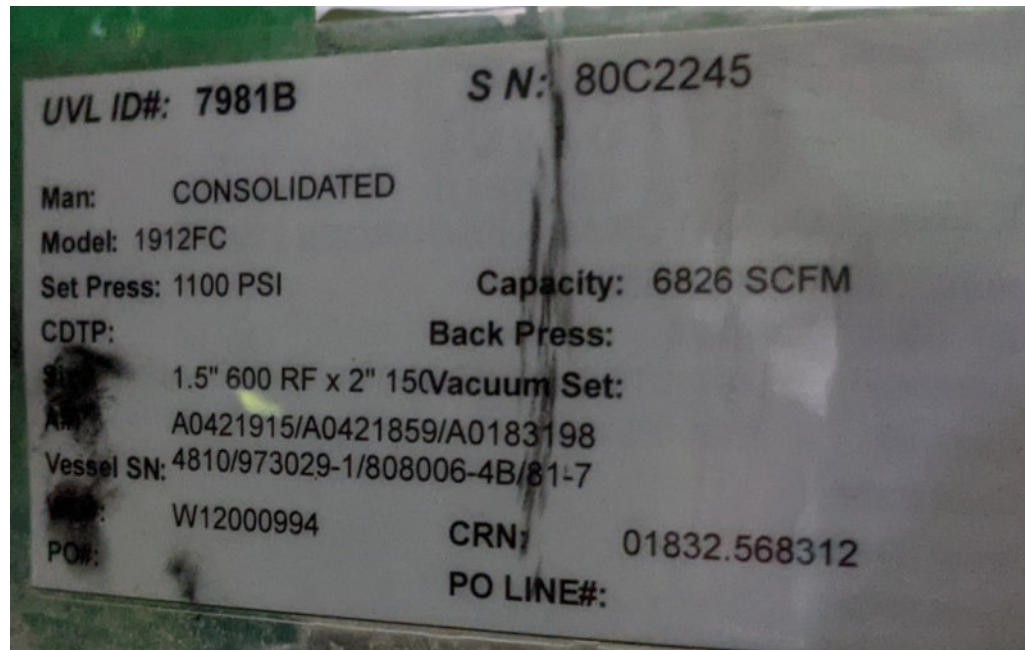
PSV Data

PSV COMMENTS

Broken Service Seal

PRESSURE EQUIPMENT										AB-506 INTERVAL							
DISTRICT	AB - OIL & NATURAL GAS					SHELL	TUBE			Air cooled heat exchangers							
FACILITY	Armada Gas Plant					MAWT	300	F		GRADE	YEARS			REG			
A#	YR 1980					MAWP	1315				Equip	PSV	UT				
SERIAL #	808006.4B					PSV	1100		psi		3	10	6	10	X		
CRN	D6028.23						PSV CRN 01832.568				INSPECTION TYPE						
EQUIP#							SERVICED 9/9/2020			VE	VI	MT	PT	ET	UT		
STATUS	IN SERVICE					UNIT	K301			X					X		
MANUFACTURER	AIR-X-CHANGERS					INSPECTION RESULT:											
DH LSD						L	Ft	OD	.33	Ft	NCR-OPERATIONS						
REPAD	0	UNIQUE ID C65691										NCR-REGULATORY/ADMIN					
										ACTION ITEM RAISED							
										REPAIR REQUIRED							
										SUITABLE FOR SERVICE					X		
										RECOMMENDATIONS:							
										VE Inspection: Service PSV

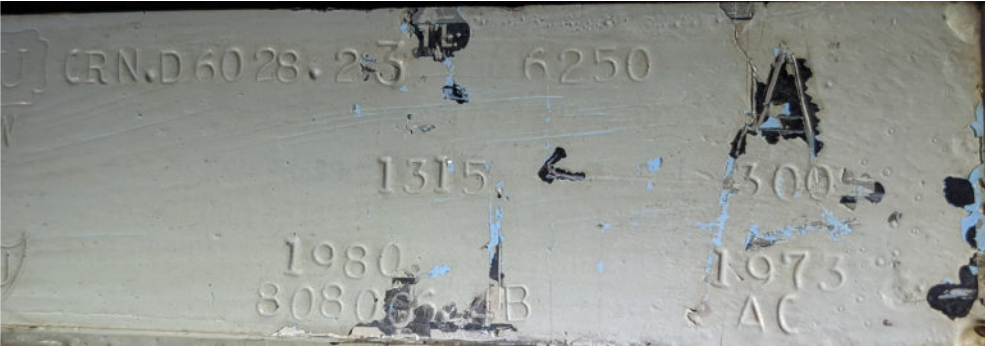
Pressure Protection:	Fair	The PSV Set Pressure (1100 psi) is suitable for the MAWP (1315 psi) PSV service seal broken
NDE Summary:	Good	No corrosion was found with the ultrasonic inspection.
Manway Davits/Quick Closure:	N/A	No Manway
Nameplate:	Good	Nameplate is legible and readily accessible and securely affixed
Code Variance:

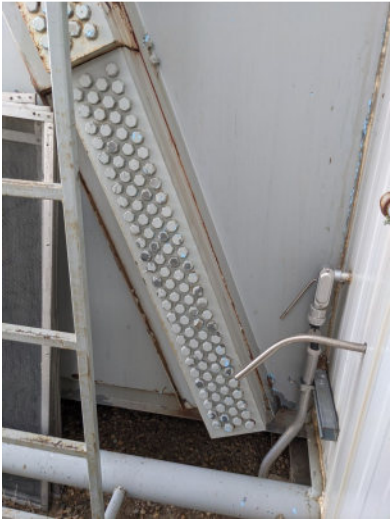
Overview

Fit For Service:	Fit For Service.
Inspection Summary:	Vessel is in good visual condition. PSV service seal is broken
Recommendations:	Service PSV

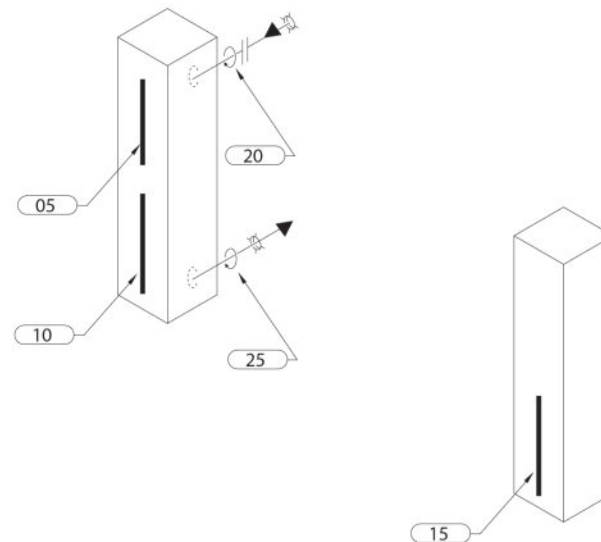
REPORT # 808006.4B_GRADY INSPECTION LTD VE UT INSP_31MAR2022
LSD 01-18-017-18W4M FACILITY Armada Gas Plant
DH-LSD FIELD Red Deer District
Jur # DWG 1 Location:
Ser # 808006.4B

Ser #	808006.4B		Inspection Dates and Thickness Values (mm)																		# of Insp	% Norm Wall Loss	Corrosion Rates			Rem Life Date	Rem Life (yrs)	Next Insp Date	Insp Int (yrs)	Inspection Comments
			CML#	Nom	CA/Tol	SFlag	STmin	PTmin	> Tmin	Comp Type	Pipe Size	Code	MOP	Baseline		3rd Last		2nd Last		Last			ST	LTn	LTi					
												Date	Min Ave		Date	Min Ave		Date	Min Ave											
05	3.2	3.2	10.8	5.4	5.4	Shell		UG27ShellInt	1315			3/31/22	23.5	23.7						1	-640%						3/28/2032	10.0		
10	3.2	3.2	10.8	5.4	5.4	Shell		UG27ShellInt	1315			3/31/22	23.2	23.3						1	-631%						3/28/2032	10.0		
15	3.2	3.2	10.8	5.4	5.4	Shell		UG27ShellInt	1315			11/28/17	23.2	24.2				3/31/22	22.9	23.1	2	-621%	0.07				3/28/2032	10.0		
20	8.6			5.3	5.3	Nozzle	4" XS 80--(8.6mm)	UG45Nozzle	1315			3/31/22	8.5	8.8						1	1%	0.00		10/15/3386		3/28/2032	10.0			
25	8.6			5.3	5.3	Nozzle	4" XS 80--(8.6mm)	UG45Nozzle	1315			3/31/22	8.0	8.6						1	7%	0.01		6/19/2214		3/28/2032	10.0
