01-18-017-18W4M
3RD STG SUCTION SCRUBBER
A0416399
REPORT # A#0416399_GRADY INSPECTION LTD VE UT INSP_31MAR2022

GRADY
INSPECTION LTD

External Inspection - (Vessel)		Date	3/30/2022		Phone:403-793-7697

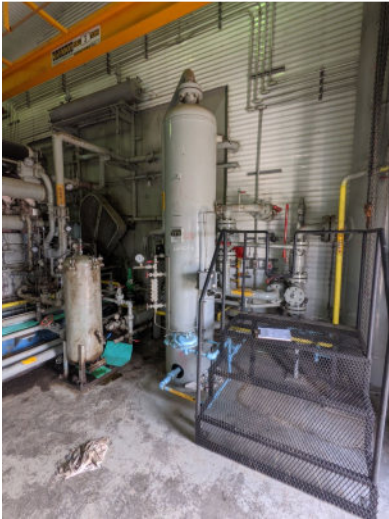
Overview

VE Inspection:
Fit For Service. Vessel is in good visual condition.
PSV due for service
UT Inspection:
No corrosion was found with the ultrasonic inspection.
