01-18-017-18W4M
2ND STG COOLER
808006.3BC65699
REPORT # 808006.3B_GRADY INSPECTION LTD VE UT INSP_30MAR2022

GRADY
INSPECTION LTD

PRESSURE EQUIPMENT										AB-506 INTERVAL						
DISTRICT	AB - OIL & NATURAL GAS					SHELL	TUBE			Air cooled heat exchangers						
FACILITY	Armada Gas Plant					MAWT	300			F	GRADE	YEARS			REG	
A#	YR 1980					MAWP	1315					Equip	PSV	UT		
SERIAL #	808006.3B						PSV	870				3	10	6		10
CRN	D6028.23						PSV CRN	0G0449.2			INSPECTION TYPE					
EQUIP#							SERVICED	3/21/2016			VE	VI	MT	PT	ET	UT
STATUS	IN SERVICE					UNIT				X						X
MANUFACTURER	AIR-X-CHANGERS					INSPECTION RESULT:										
DH LSD						L	Ft	OD	.43	Ft	NCR-OPERATIONS					
REPAD	UNIQUE ID C65699										NCR-REGULATORY/ADMIN					
										ACTION ITEM RAISED					X	
										REPAIR REQUIRED						
										SUITABLE FOR SERVICE					X	
RECOMMENDATIONS:																
VE Inspection: Mitigate pipe fretting

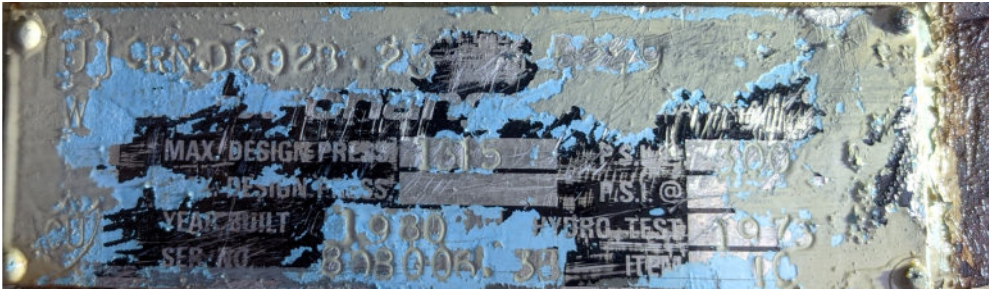
NDE Summary:	Good	No corrosion was found with the ultrasonic inspection.
Manway Davits/Quick Closure:	N/A	No Manway
Nameplate:	Good	Nameplate is legible and readily accessible and securely affixed
Code Variance:

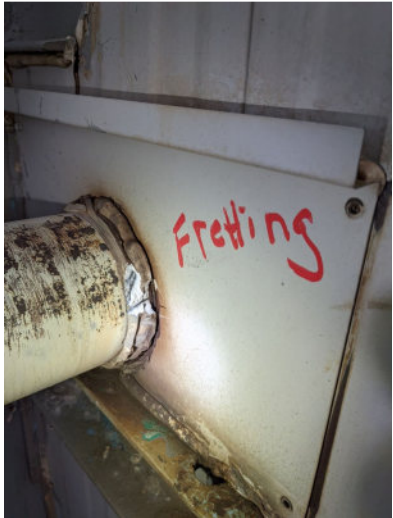
Fretting

VE Inspection:
Fit For Service. Vessel is in good visual condition.
Minor fretting on piping from wall contact
UT Inspection:
No corrosion was found with the ultrasonic inspection.

Fit For Service:	Fit For Service.
Inspection Summary:	Vessel is in good visual condition. Minor fretting on piping from wall contact
Recommendations:	Mitigate pipe fretting
