01-18-017-18W4M
GAS/GAS EXCHANGER
A0190928
REPORT # A#0190928_GRADY INSPECTION LTD VE VI UT INSP_2MAY2022

| PRESSURE EQUIPMENT | | | | | | | | | | AB-506 INTERVAL | | | | | | | | |
|---|--|--|--|---|---|---|---|---|---|---|---|---|---|---|---|---|---|---|
| DISTRICT | | AB - OIL & NATURAL GAS | | | | SHELL | | TUBE | | Refrigeration Vessels | | | | | | | | |
| FACILITY | | Armada Gas Plant | | | | MAWT | | 150 | 150 | F | GRADE | | YEARS | | | REG | | |

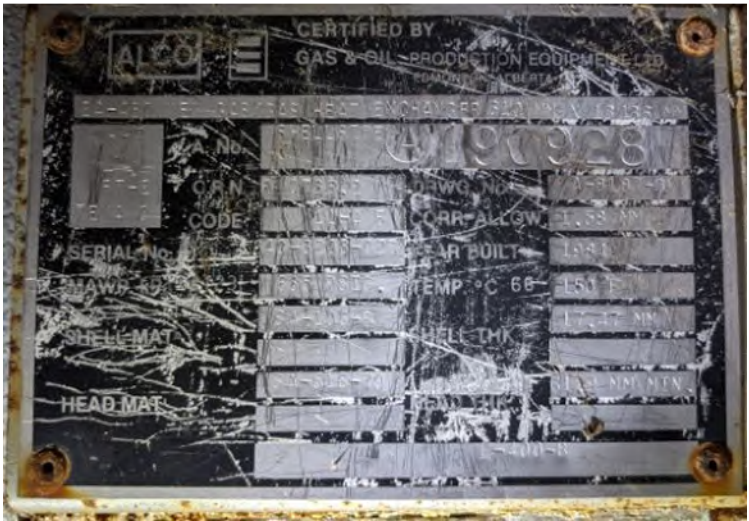
Shellside Nameplate

| External Inspection Items | G/F/P | Comments |
|---|---|--|
| Nameplate: | Good | Nameplate is legible and readily accessible and securely affixed |

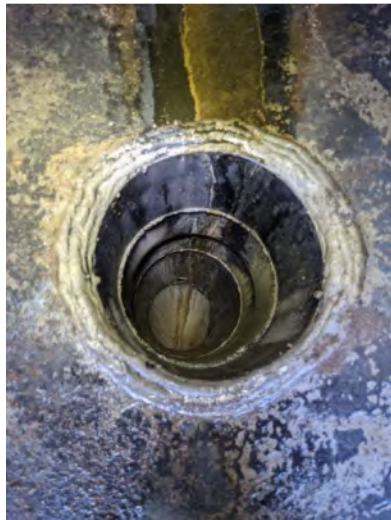
Typical Nozzle

| External Inspection Items | G/F/P | Comments |
|---|---|--|
| Nozzles, Piping and Connections: | Good | Nozzles and piping in good visual condition |

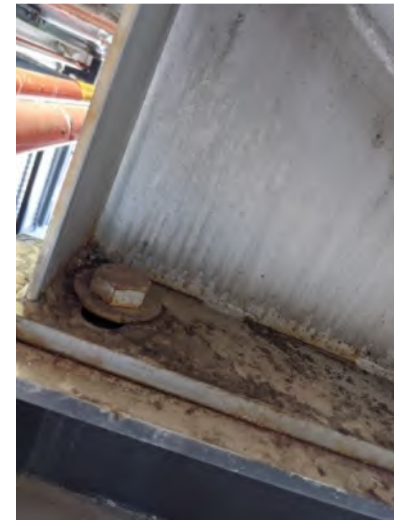
Anchor Bolt

| External Inspection Items | G/F/P | Comments |
|---|---|--|
| Foundations and Supports: | Good | Unable to view saddle attachment to shell |

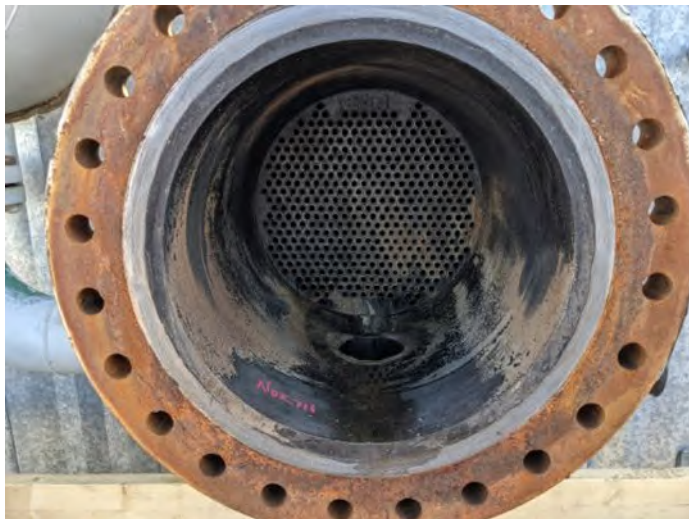
North overview

| Internal Inspection Items | | G/F/P | Comments |
|---|---|---|--|
| Head (1): | North | Good | Blind flange. No erosion, corrosion or mechanical damage observed. |
| Channel Section: | | Good | Both North and South channels are in good visual condition. No notable corrosion, erosion, mechanical damage or weld defects observed. |

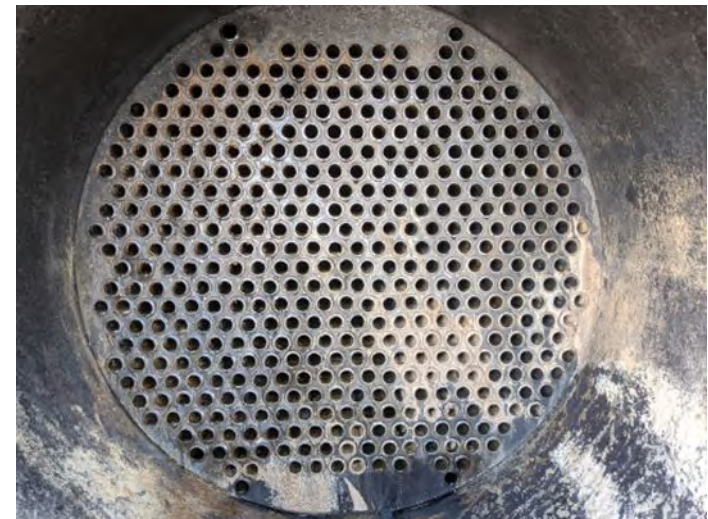
| Internal Inspection Items | | G/F/P | Comments |
|---|---|---|--|
| Bundle / Tubes: | | Good | Minor visible solid build up in a few tubes. Will not affect process. |

North End - minimal solid build up in tubes.

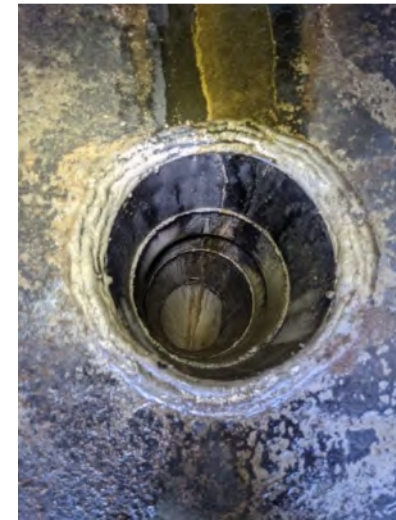
**Typical Nozzle**

| Internal Inspection Items | | G/F/P | Comments |
|---|---|---|--|
| Nozzles / Manways: | | Good | No notable corrosion, erosion, mechanical damage or weld defects observed. |

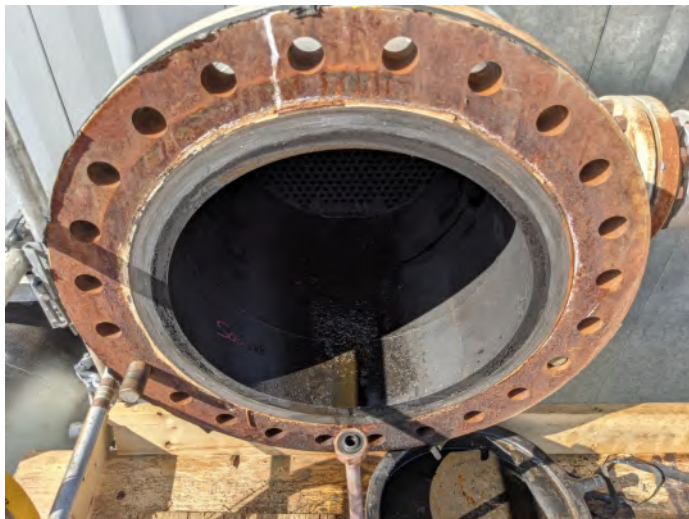
**South Overview**

| Internal Inspection Items | | G/F/P | Comments |
|---|---|---|--|
| Head (2): | South | Good | Blind flange. No erosion, corrosion or mechanical damage observed. |

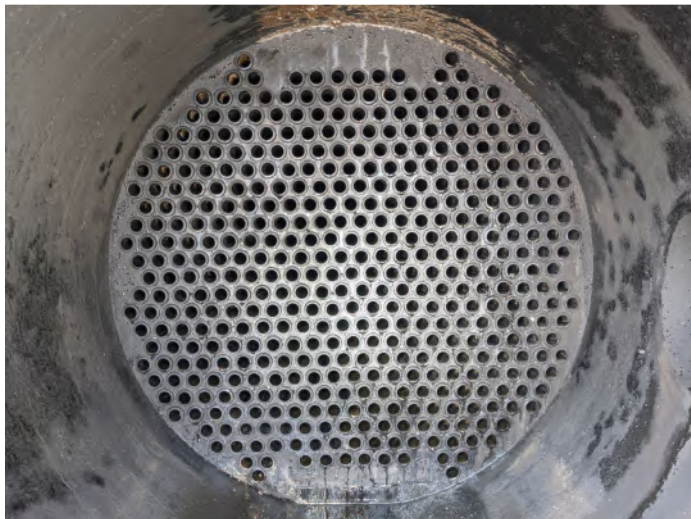
South end. minimal solid build up in tubes.

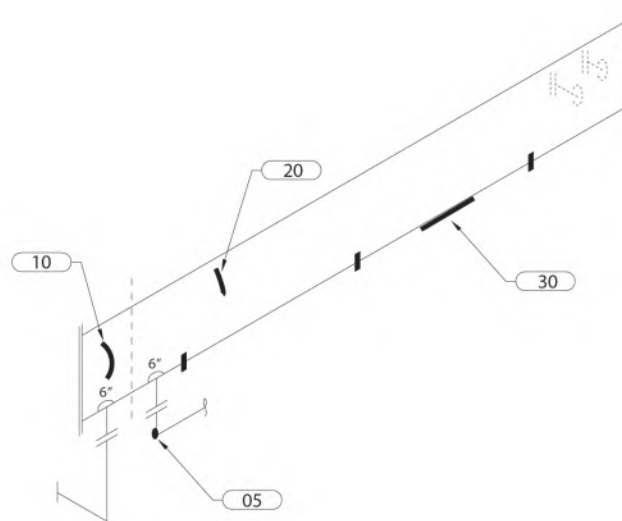
DWG 1

| Ser # | Inspection Dates and Thickness Values (mm) | | | | | | | | | | | | | | | | | | | | | | | | |
|---|--|---|---|---|---|---|---|---|---|---|---|---|---|---|---|---|---|---|---|---|---|---|---|---|--|
| 05 | 7.1 | 6.2 | 3.3 | 2.8 | 2.9 | 2.9 | Elbow | 6" | STD 40--(7.1mm) | API570 | 685 | 5/2/22 | 7.0 | 7.5 | | | 1 | 1% | 0.00 | | 1/5/3601 | | 4/29/2032 | 10.0 | |
| 10 | 17.5 | 17.4 | 27.0 | | 13.5 | 13.5 | Shell | | | UG27ShellInt | 685 | 5/2/22 | 16.4 | 16.7 | | | 1 | 6% | 0.03 | | 6/19/2127 | | 4/29/2032 | 10.0 | |
| 20 | 17.5 | 17.4 | 27.0 | | 13.5 | 13.5 | Shell | | | UG27ShellInt | 685 | 5/2/22 | 17.2 | 17.5 | 5/2/22 | 17.0 | 17.3 | 2 | 3% | | | | 4/29/2032 | 10.0 | |
| 30 | 17.5 | 17.4 | 27.0 | | 13.5 | 13.5 | Shell | | | UG27ShellInt | 685 | 5/2/22 | 17.5 | 17.8 | 5/2/22 | 17.4 | 17.7 | 2 | 0% | | | | 4/29/2032 | 10.0 | |
