PRESSURE EQUIPMENT

DISTRICT SHELL TUBE

Ultrasonic Report #: C87360_GRADY INSPECTION LTD VE UT INSP_31MAR2022

Armada Gas Plant

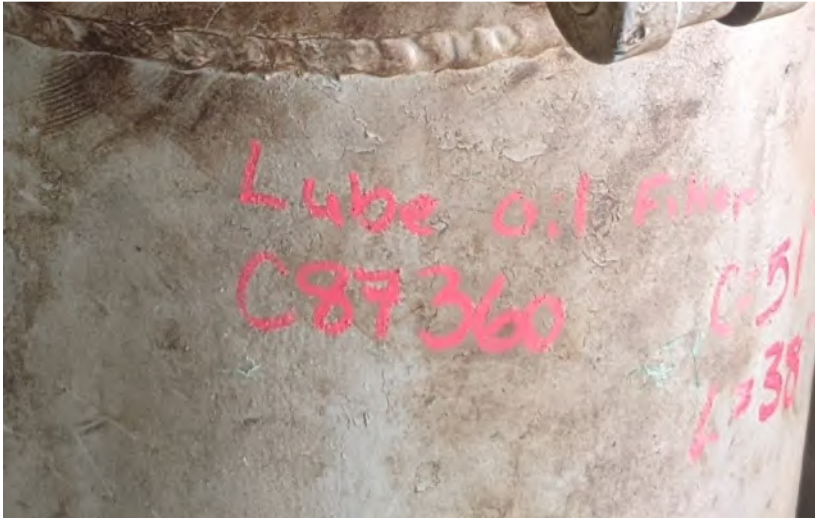
**Nameplate**

Nameplate:	Fair	Nameplate missing
-------------------	------	-------------------

VE Inspection:
Repair or replace nozzle
Confirm vessel has over pressure protections.
Install nameplate. Confirm variables, including CRN.

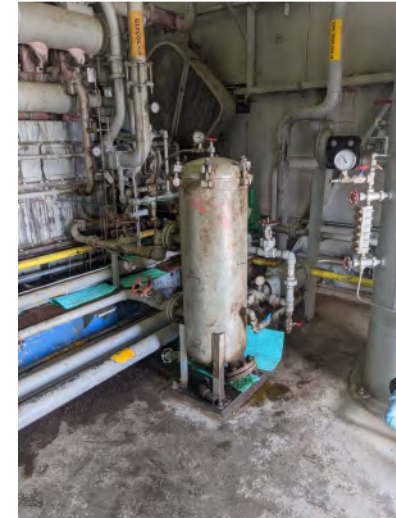
**Overview**

LSD	01-18-017-18W4M	Facility	Armada Gas Plant		8 Sarah King Crt E Brooks, Alberta, T1R 0J8			
DH-LSD		Field	Red Deer District		grady.rustebakke@gmail.com			
Jurisdiction #								
Fit For Service:		Not Fit For Service.						
Inspection Summary:		Nozzle CML below Tmin NCR. No PSV identified. NCR. No nameplate. Unknown CRN. Minor weeping from 1" drain plug on south side of vessel.						
Recommendations:		Repair or replace nozzle Confirm vessel has over pressure protections. Install nameplate. Confirm variables, including CRN.						
External Inspection Items		G/F/P	Comments					
General Condition:		Good	No notable external corrosion, mechanical damage, areas of wear/fretting, distortion, misalignment, current leaks, or visible weld defects.					
External Coating:		Good	Vessel is in good visual condition. Paint is intact and well adhered to the vessel. Vessel is indoors.

Insulation / Cladding:		N/A	Non insulated vessel					
Nozzles, Piping and Connections:		Fair	Minor weeping from 1" drain plug on south side of vessel. Non-repad nozzles: 3 Repad nozzles: 0					
Buried Vessels:		Good	Above Ground					
Ladders, Platforms and Walkways:		N/A	No attached ladder or platform					
Foundations and Supports:		Good	Anchor bolts fully engaged Building is secure Concrete is intact with no visible deficiencies					
Shell:.		Good	No notable external corrosion, mechanical damage, areas of wear/fretting, distortion, misalignment, current leaks, or visible weld defects.					
Saddles / Skirts:		Good	Saddle is in good visual condition					
Grounding:		Good	Ground Wire is secure Grounded through piping system					
Gauges and Instrumentation:		Fair	Shell Gauge (0 - 200 @ 30 psi) Temp Gauge (- @) MAWP / MAWT not known. Unable to determine suitability of pressure gauge					
Pressure Protection:		Poor	No pressure protection found, ensure vessel is PPSD.

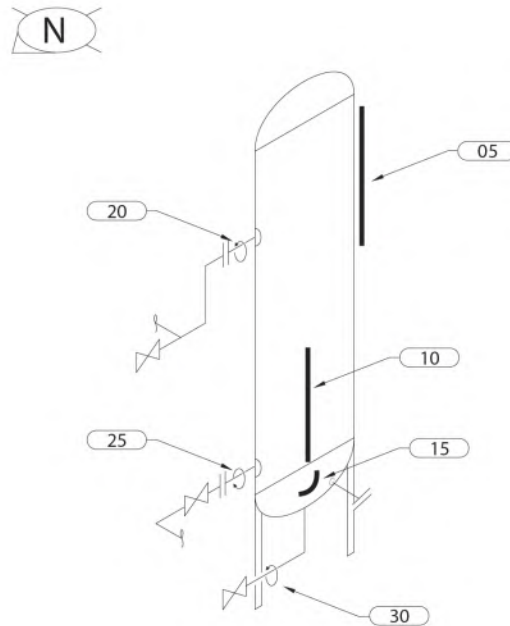
REPORT # C87360_GRADY INSPECTION LTD VE UT INSP_31MAR2022
LSD 01-18-017-18W4M FACILITY Armada Gas Plant
DH-LSD FIELD Red Deer District
Jur # DWG 1 Location:
Ser #

NDE Summary:		Poor	45% (2.5 mm) wall loss found on Nozzle CML 25 T-Nominal: (5.5 mm) T-Actual: (3 mm) T-Required: (4.8 mm) CR: .06RL: (-29.72 years) *Unable to offer alternate nozzle calculation based on Shell Tmin, as there are no known variables.					
Manway Davits/Quick Closure:		N/A	No Manway.

Ser #	Inspection Dates and Thickness Values (mm)																											
CML#	Nom	CA/Tol	Inspection Data				Comp Type	Pipe Size	Code	MOP	Baseline		3rd Last		2nd Last		Last		# of Insp	% Nom Wall Loss	Corrosion Rates			Rem Life Date	Rem Life (yrs)	Next Insp Date	Insp Int (yrs)	Inspection Comments
			SFlag	STmin	PTmin	> Tmin					Date	Min Ave	Date	Min Ave	Date	Min Ave	Date	Min Ave			ST	LTn	LTi					
05	10.0	10.0	0.6	0.3	0.3	Shell		UG27ShellInt	15	3/31/22	9.9	10.2							1	1%	0.00					3/28/2032	10.0	
10	10.0	10.0	0.6	0.3	0.3	Shell		UG27ShellInt	15	3/31/22	9.2	10.0							1	8%	0.02		10/15/2476		3/28/2032	10.0		
15	10.0	10.0	0.3	0.3	0.3	Head		UG32HeadEll	15	3/31/22	10.2	10.5							1	-2%					3/28/2032	10.0		
20	5.5		4.8		4.8	Nozzle	3" STD 40--(5.5mm)	UG45Nozzle	15	3/31/22	5.9	6.1							1	-7%					3/28/2032	10.0		
25	5.5		4.8		4.8	Nozzle	3" STD 40--(5.5mm)	UG45Nozzle	15	3/31/22	3.0	5.5							1	45%	0.06		7/19/1992	-29.7	3/31/2022	0.0	Min at 06:00
