01-18-017-18W4M
PROPANE SURGE DRUM
A0197574
REPORT # A#0197574_GRADY INSPECTION LTD VE UT INSP_1APR2022

PRESSURE EQUIPMENT						AB-506 INTERVAL																			
DISTRICT		AB - OIL & NATURAL GAS		SHELL TUBE		Upstream pressure vessels not																			
FACILITY		Armada Gas Plant		MAWT		150		F		GRADE		YEARS		REG											
A#		A0197574		YR		1984		MAWP		250		psi		Equip		PSV		UT		X					
SERIAL #				PSV		250		psi		3		10		6		10		X							
CRN		F0749.2		PSV CRN		01832.568																			
EQUIP#				SERVICED		3/21/2016																			
STATUS		IN SERVICE		UNIT		Refridge comp				VE		VI		MT		PT		ET		UT					
										X										X					
MANUFACTURER						ALCO GAS & OIL PRODUCTION EQUIPMENT LTD.						INSPECTION TYPE													
DH LSD				L		6		Ft		OD		2		Ft		INSPECTION RESULT:									
REPAD		0		UNIQUE ID																NCR-OPERATIONS		X			
																		NCR-REGULATORY/ADMIN							
																		ACTION ITEM RAISED							
																		REPAIR REQUIRED							
																		SUITABLE FOR SERVICE						X

LSD	01-18-017-18W4M	Facility	Armada Gas Plant		
DH-LSD		Field	Red Deer District		
Jurisdiction #		A0197574

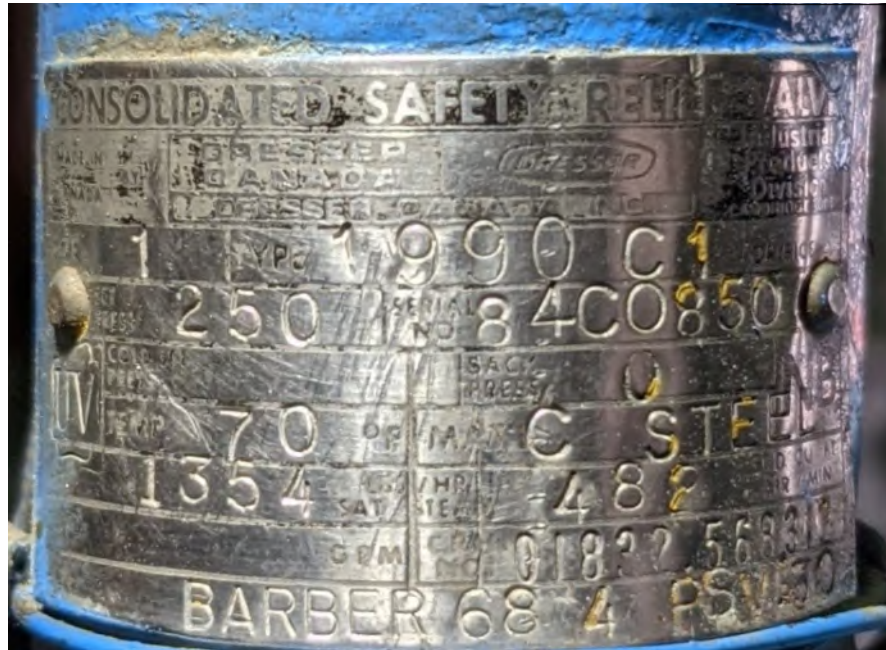
PSV Data

UVL ID#: 14382B **S N:** 84C0850

Man: CONSOLIDATED **Model:** 1990C1

Set Press: 250 PSI **Capacity:** 1354 SCFM

Car seal does not inhibit valve movement. PSV due for service

RECOMMENDATIONS:							
																		VE Inspection: Service PSV. Replace carseal.

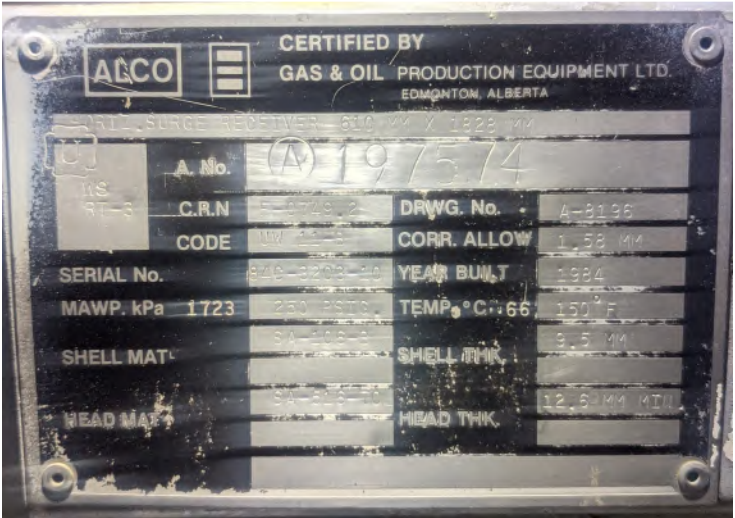
Gauges and Instrumentation:	Good	<div>Shell Gauge (0 - 300 @ 100 psi)</div> <div>Temp Gauge (0 - 250 @ 62 F)</div> <div>Gauge is clear, colorless and correct for the MAWT. Gauge is clear, colorless and correct for the MAWP.</div>
Pressure Protection:	Fair	The PSV Set Pressure (250 psi) is suitable for the MAWP (250 psi) PSV Due for Service, not yet exceeding six months or 10% of Interval PSV inlet and outlet block valve carseals are installed in such a manor as to allow operation with out removing the car seal.
NDE Summary:	Good	No corrosion was found with the ultrasonic inspection.
Manway Davits/Quick Closure:	N/A	No Manway
Nameplate:	Good	Nameplate is legible and readily accessible and securely affixed

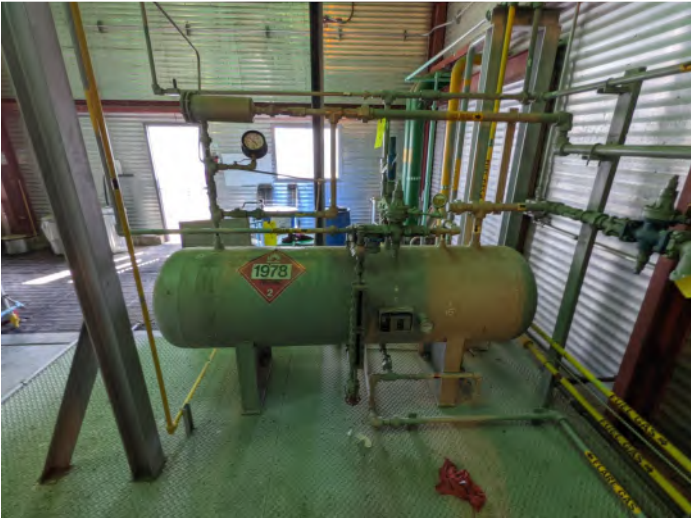
Overview

Fit For Service:	Fit For Service.
Inspection Summary:	Vessel is in good visual condition. PSV block valve carseal does not inhibit closure of valve. PSV due for service
Recommendations:	Service PSV. Replace carseal.
