| Ultrasonic Report #: A#0408942_GRADY INSPECTION LTD VE UT INSP_31MAR2022 | | | | | |

| ULTRASONIC SET | | | COMPONENT DETAILS | | | | CODE | | | | | |
|---|---|---|---|---|---|---|---|---|---|---|---|---|
| SCOPE | | As requested by Dustin Rumohr an ultrasonic inspection was completed on the FUEL GAS SCRUBBER | | | | | | | | | | |

| External Inspection - (Vessel) | | Date | 3/30/2022 | Phone:403-793-7697 | |

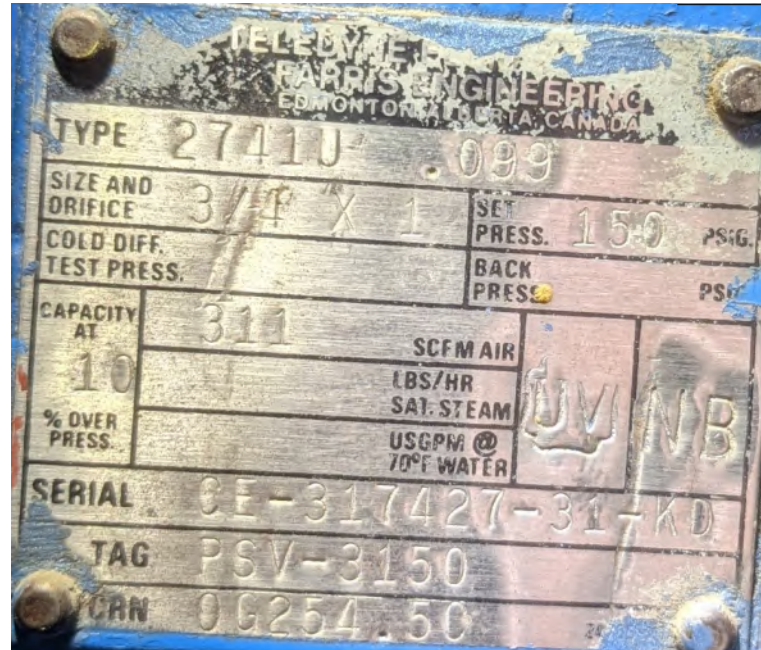
PSV Data

| UVL ID#: 14971B | | S N: CE-317427-31-KD | |
| Man: FARRIS | | Model: 2741U | |
| Set Press: 150 PSI | | Capacity: 311 SCFM | |

| Serviced By: | UNIFIED VALVE GROUP LTD | 3/21/2016 |

| Recommendations: | service PSV |

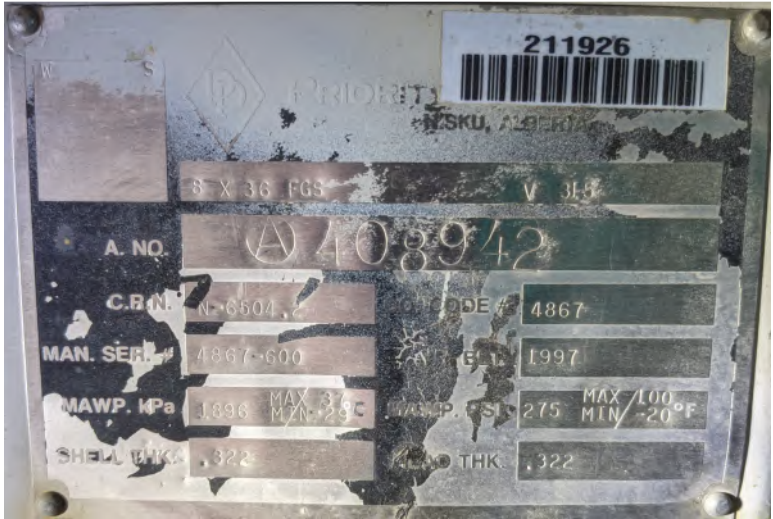
| External Inspection Items | G/F/P | Comments |
|---|---|--|
| Nameplate: | Good | Nameplate is legible and readily accessible and securely affixed |

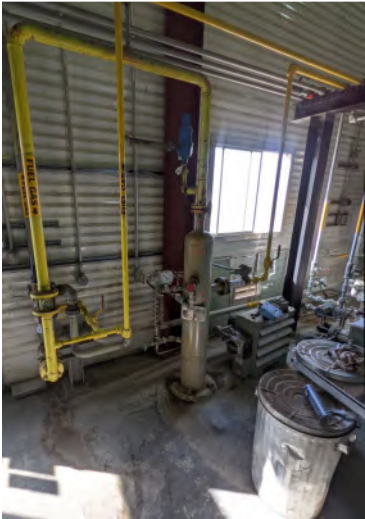
Overview

| Inspection Summary: | Vessel is in good visual condition. PSV due for service |

| External Inspection Items | G/F/P | Comments |
|---|---|--|
| External Coating: | Good | Vessel is in good visual condition. Paint is intact and well adhered to the vessel. Vessel is indoors. |

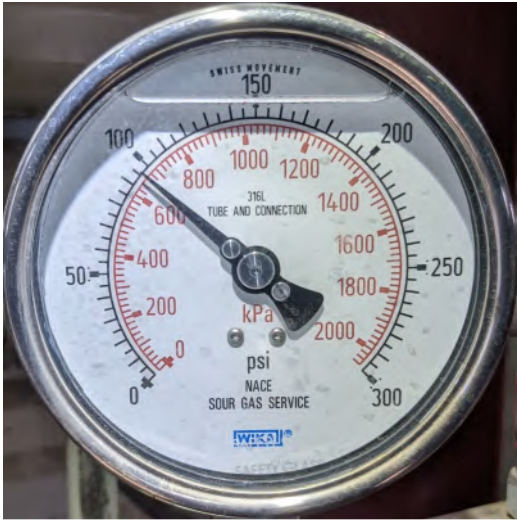
Pressure Gauge

| External Inspection Items | G/F/P | Comments |
|---|---|--|
| Gauges and Instrumentation: | Good | <div>Shell Gauge (0 - 300 @ 95 psi) Temp Gauge (- @)</div> <div>No temperature gauge found. Gauge is clear, colorless and correct for the MAWP.</div> |
