01-18-017-18W4M
FUEL GAS SEPARATOR
89N00543C65698
REPORT # 89N00543_GRADY INSPECTION LTD VE UT INSP_1APR2022

PRESSURE EQUIPMENT										AB-506 INTERVAL																								
DISTRICT					SHELL					TUBE					Fuel gas scrubbers																			
FACILITY					MAWT					100					F																			
A#					YR					1990 <th colspan="5">MAWP</th> <td colspan="5">150</td> <td colspan="5"></td> <td colspan="5">psi</td>					MAWP					150										psi				
SERIAL #					SN 89N00543										PSV					150										psi				
CRN					H-0582.123										PSV CRN					0G0321.23														
EQUIP#															SERVICED					4/19/2021														
STATUS					IN SERVICE <th colspan="5">UNIT</th> <td colspan="5">Refridge</td> <td colspan="6"></td>					UNIT					Refridge																			
MANUFACTURER										NUSCO PIPE & SUPPLY LTD										INSPECTION TYPE														
DH LSD										L 2.5 Ft OD .67 Ft										VE		VI		MT		PT		ET		UT				
REPAD										0		UNIQUE ID C65698										X								X				
																				INSPECTION RESULT:

External Inspection - (Vessel)		Date	3/30/2022	Phone: 403-793-7697 8 Sarah King Crt E Brooks, Alberta, T1R 0J8 grady.rustebakke@gmail.com

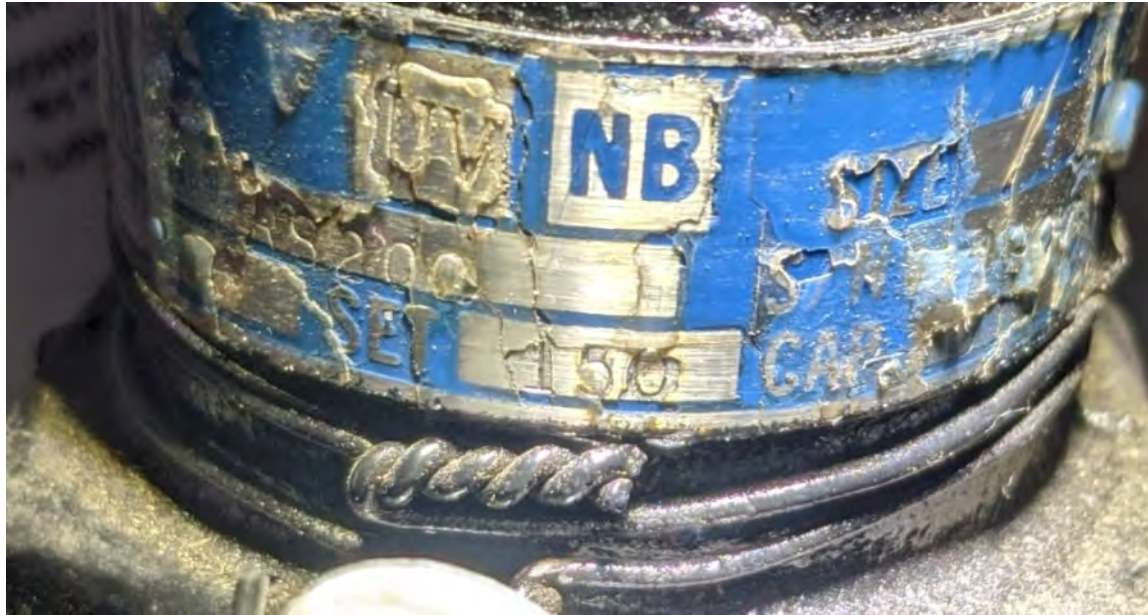
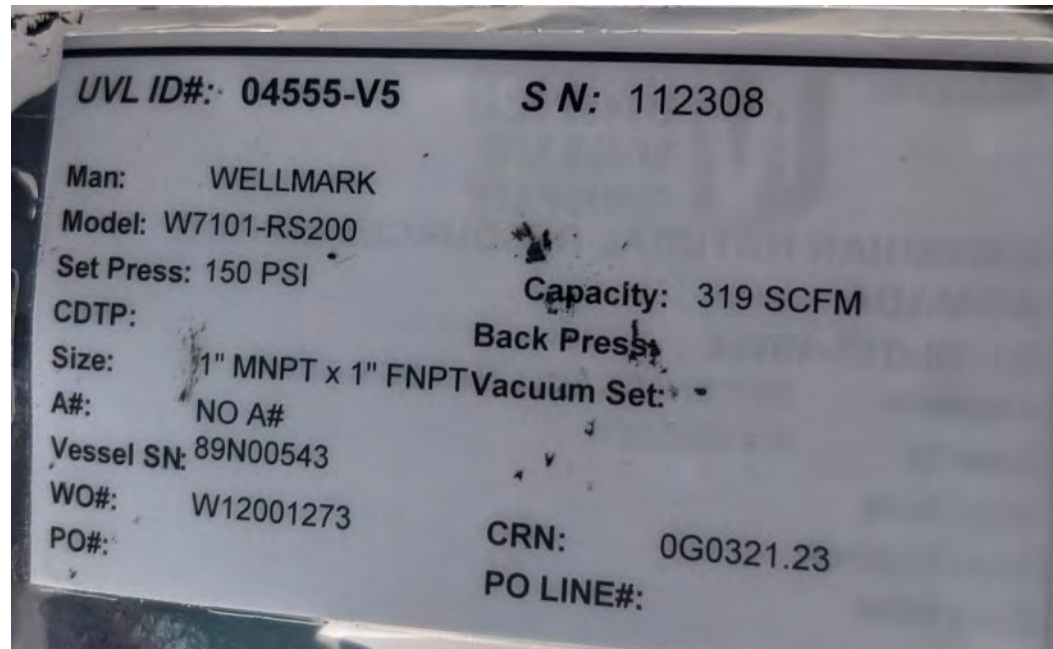
PSV Data
LSD

VE Inspection:
Fit For Service. NCR. No CRN on PSV nameplate.
Year built is assumed
PSV discharges 24" from ground
UT Inspection:
No corrosion was found with the ultrasonic inspection.

Pressure Protection:	Fair	The PSV Set Pressure (150 psi) is suitable for the MAWP (150 psi) No CRN on PSV nameplate PSV discharge pipe is 24" from ground, recommend installing upward elbow and pipe.
NDE Summary:	Good	No corrosion was found with the ultrasonic inspection.
Manway Davits/Quick Closure:	N/A	No Manway
Nameplate:	Fair	Nameplate is legible and readily accessible and securely affixed

NCR-OPERATIONS				X										
																				NCR-REGULATORY/ADMIN														
																				ACTION ITEM RAISED														
																				REPAIR REQUIRED														
																				SUITABLE FOR SERVICE				X										
																				RECOMMENDATIONS:														
																				VE Inspection: Confirm PSV CRN. Confirm year built Consider installing downward elbow on PSV discharge line to direct away from passersby

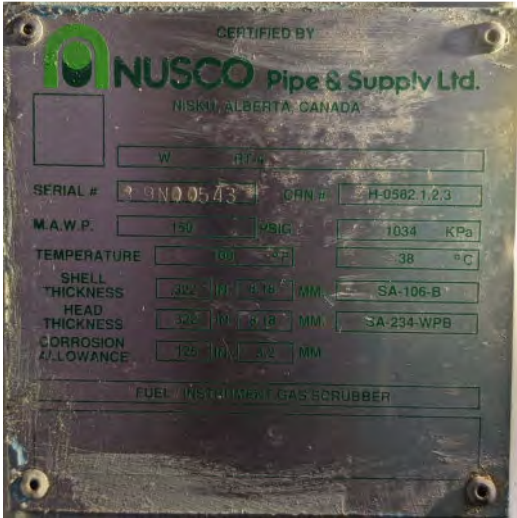
Nameplate

Year built is not on data plate.

Fit For Service:	Fit For Service.
Inspection Summary:	NCR. No CRN on PSV nameplate. Year built is assumed PSV discharges 24" from ground
Recommendations:	Confirm PSV CRN. Confirm year built Consider installing downward elbow on PSV discharge line to direct away from passersby

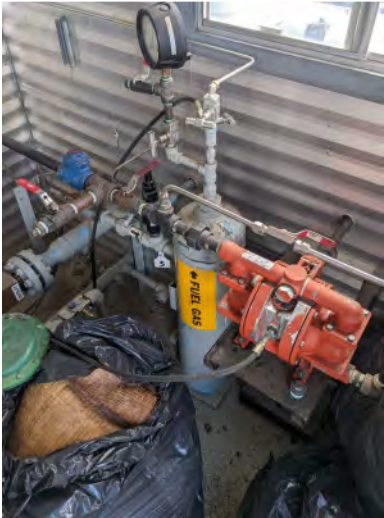
Overview

External Inspection Items	G/F/P	Comments
General Condition:	Good	No notable mechanical damage, areas of wear/fretting, distortion, misalignment, or visible weld defects.
External Coating:	Good	Vessel is in good visual condition. Paint is intact and well adhered to the vessel. Vessel is indoors.
Insulation / Cladding:	N/A	Non insulated vessel
Nozzles, Piping and Connections:	Good	Number of nozzles repaded: 0 Number of nozzles without repad: 0 Nozzles and piping in good visual condition
Buried Vessels:	N/A	Above Ground
Ladders, Platforms and Walkways:	N/A	No attached ladder or platform
Foundations and Supports:	Good	Welds secure Building is secure Building on planks.
Shell:.	Good	No notable mechanical damage, areas of wear/fretting, distortion, misalignment or visible weld defects.
Saddles / Skirts:	Good	Saddle is in good visual condition
Grounding:	Good	Grounded through piping system
Gauges and Instrumentation:	Fair	Shell Gauge (0 - 100 @ 58 psi) Temp Gauge (- @) Gauge is not suitable for MAWP nor PSV set pressure

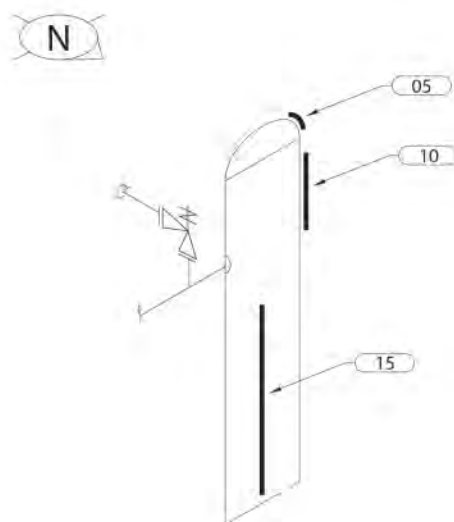
Jur # **DWG** 1 **Location:**

Ser #	SN 89N00543						Inspection Dates and Thickness Values (mm)																									
	CML#	Nom	CA/Tol	SFlag	STmin	PTmin	> Tmin	Comp Type	Pipe Size	Code	MOP	Baseline		3rd Last		2nd Last		Last		# of Insp	% Nom Wall Loss	Corrosion Rates			Rem Life	Rem Life (yrs)	Next Insp Date	Insp Int (yrs)	Inspection Comments			
												Date	Min Ave	Date	Min Ave	Date	Min Ave	Date	Min Ave			ST	LTn	LTi	Date							
05	8.2	8.1	1.3		1.3	1.3		Head		UG32HeadElli	150	4/3/14	9.4			11/30/17	9.7			4/1/22	9.4	10.0	3	-15%					3/29/2032	10.0		
10	8.2	8.1	2.7		1.3	1.3		Shell		UG27ShellInt	150	4/3/14	8.3			11/30/17	8.2			4/1/22	7.9	8.2	3	3%	0.07		0.05	6/9/2117		3/29/2032	10.0	
15	8.2	8.1	2.7		1.3	1.3		Shell		UG27ShellInt	150	11/30/17	8.5	8.6						4/1/22	8.1	8.3	2	1%	0.09					3/29/2032	10.0
