01-18-017-18W4M
2ND STG COOLER
808006.3BC65699
REPORT # 808006.3B_GRADY INSPECTION LTD VE UT INSP_30MAR2022

RESULTS OF INSPECTION:

VE Inspection:
Fit For Service. Vessel is in good visual condition.
Minor fretting on piping from wall contact
UT Inspection:
No corrosion was found with the ultrasonic inspection.

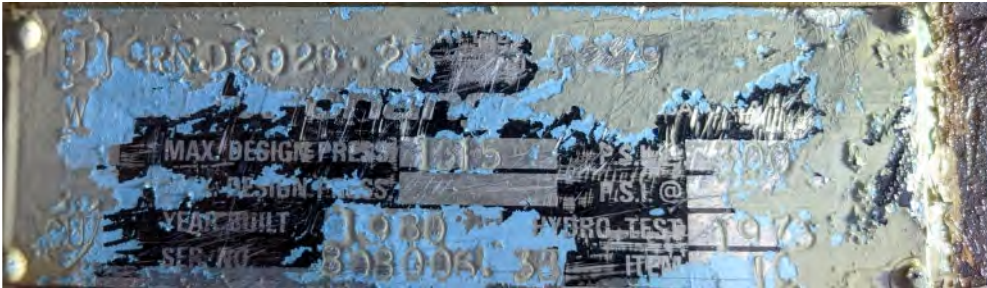
NDE Summary:	Good	No corrosion was found with the ultrasonic inspection.
Manway Davits/Quick Closure:	N/A	No Manway
Nameplate:	Good	Nameplate is legible and readily accessible and securely affixed
Code Variance:

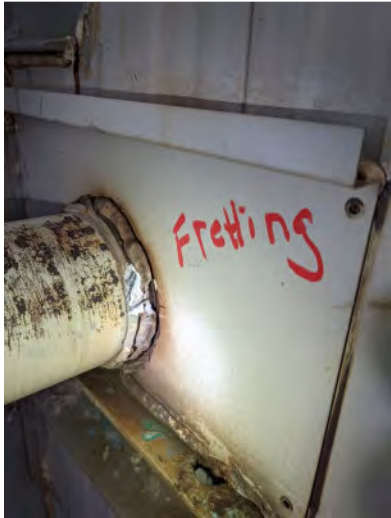
Fretting

Fit For Service:	Fit For Service.
Inspection Summary:	Vessel is in good visual condition. Minor fretting on piping from wall contact
Recommendations:	Mitigate pipe fretting

PRESSURE EQUIPMENT							AB-506 INTERVAL						
DISTRICT	AB - OIL & NATURAL GAS				SHELL	TUBE		Air cooled heat exchangers					
FACILITY	Armada Gas Plant			MAWT	300		F	GRADE					
A#	YR	1980	MAWP	1315		psi	YEARS						
							Equip	PSV	UT		REG		
SERIAL #	808006.3B		PSV	870		psi	3	10	6	10	X		
CRN	D6028.23		PSV CRN	0G0449.2			INSPECTION TYPE						
EQUIP#			SERVICED	3/21/2016			VE	VI	MT	PT	ET	UT	
STATUS	IN SERVICE		UNIT				X					X	
MANUFACTURER	AIR-X-CHANGERS						INSPECTION RESULT:						
DH LSD				L	Ft	OD	.43	Ft	NCR-OPERATIONS				
REPAD	UNIQUE ID C65699						NCR-REGULATORY/ADMIN						
							ACTION ITEM RAISED				X		
							REPAIR REQUIRED						
							SUITABLE FOR SERVICE				X		
							RECOMMENDATIONS:						
							VE Inspection: Mitigate pipe fretting

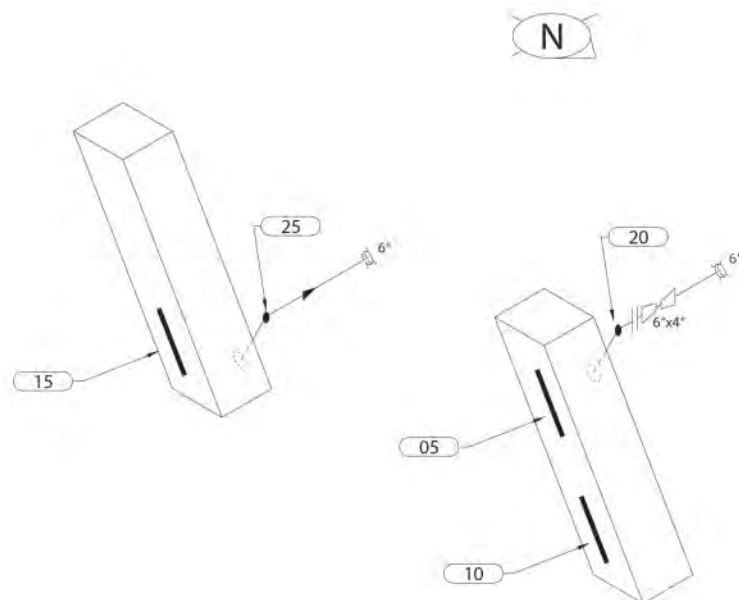
Jur # **DWG** 1 **Location:**

Ser #		808006.3B		Inspection Dates and Thickness Values (mm)																											
CML#	Nom	CA/Tol	SFlag	STmin	PTmin	> Tmin	Comp	Type	Pipe Size	Code	MOP	Baseline		3rd Last		2nd Last		Last		# of Insp	% Nom Wall Loss	Corrosion Rates			Rem Life Date	Rem Life (yrs)	Next Insp Date	Insp Int (yrs)	Inspection Comments		
												Date	Min Ave	Date	Min Ave	Date	Min Ave	Date	Min Ave			ST	LTn	LTi							
05	6.0	5.3	3.1	2.3	3.8	3.8	Elbow		4" STD 40-- (6mm)	API570	1315	11/28/17	9.0	9.2						1	-50%						11/26/2027	10.0			
10	31.8	31.8	7.8		3.9	3.9	Shell			UG27ShellInt	1315	11/28/17	23.0	23.3						1	28%	0.23		10/5/2100		11/26/2027	10.0				
15	31.8	31.8	7.8		3.9	3.9	Shell			UG27ShellInt	1315	11/28/17	23.1	23.2						1	27%	0.23		2/27/2102		11/26/2027	10.0				
20	7.1	6.2	3.3	2.8	5.5	5.5	Elbow		6" STD 40-- (7.1mm)	API570	1315	11/28/17	7.1	7.8						1	0%					11/26/2027	10.0
