01-18-017-18W4M
FUEL GAS SEPARATOR
79-957-61C87380
REPORT # 79-957-61_GRADY INSPECTION LTD VE UT INSP_1APR2022

PRESSURE EQUIPMENT										AB-506 INTERVAL																																					
DISTRICT					SHELL					TUBE					Fuel gas scrubbers																																
FACILITY					ARMADA					MAWT					100					F																											
A#					YR					1978					MAWP					275										psi																	
SERIAL #					79-957-61										PSV					150					psi																						
CRN					D2845.2										PSV CRN					0G8841.5C																											
EQUIP#															SERVICED					6/7/2017																											
STATUS					IN SERVICE					UNIT					K101					INSPECTION TYPE																											
																				VE		VI		MT		PT		ET		UT																	
																				X										X																	
MANUFACTURER					DACRO INDUSTRIES INC					INSPECTION RESULT:																																					
DH LSD										L					4.5					Ft					OD					.55					Ft					NCR-OPERATIONS						X	
REPAD					0					UNIQUE ID					C87380					NCR-REGULATORY/ADMIN <td colspan="2"></td>

LSD	01-18-017-18W4M	Facility	Armada Gas Plant		
DH-LSD		Field	Red Deer District		
Jurisdiction #					
Serial

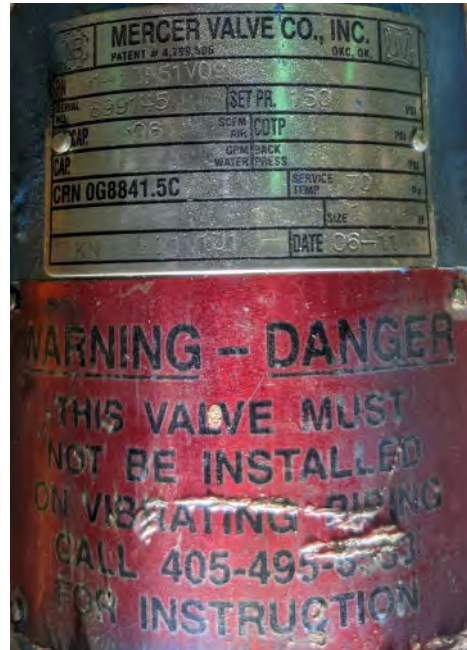
PSV Data

UVL ID#: 38071B		S N: 699145	
Man: MERCER		Model: 91-23F51V09U1	
Set Press: 150 PSI		Capacity: 908 SCFM	
Cold Diff:		Back Press: PSI	
Size: 1" MNPT		X 1.5" FNPT	
A#:			
Vessel SN:			
WO#: 613111		CRN: 0G8841.5C	
PO#:		PO Line#	
REVISION 3 / 7082014 QF-01

Not Fit For Service.

Check valve on PSV discharge line causing restriction

ACTION ITEM RAISED <td colspan="2"></td>																											
																				REPAIR REQUIRED <td colspan="2"></td>																											
																				SUITABLE FOR SERVICE <th colspan="2">X</th>						X																					
																				RECOMMENDATIONS:																											
																				VE Inspection: Remove Check valve on PSV discharge line.

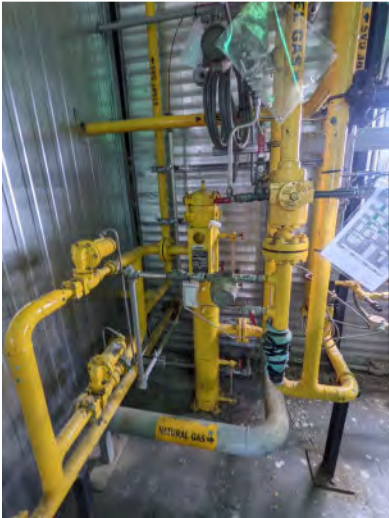
Grounding:	N/A	Not confirmed
Gauges and Instrumentation:	Good	<div>Shell Gauge (0 - 300 @ 135 psi) Temp Gauge (- @)</div> <div>Gauge is clear, colorless and correct for the MAWP.</div>
Pressure Protection:	Poor	PSV set pressure of 150 PSI is suitable for MAWP of 275PSI Restriction noted in PSV discharge piping with check valve installed.
NDE Summary:	Good	No corrosion was found with the ultrasonic inspection.
Manway Davits/Quick Closure:	N/A	No Manway.
Nameplate:	Good	Nameplate is legible and readily accessible and securely affixed
Code Variance:
