Ultrasonic Report		Date	3/30/2022	Phone: 403-793-7697 8 Sarah King Crt E Brooks, Alberta, T1R 0J8 grady.rustebakke@gmail.com	
LSD	01-18-017-18W4M	Facility	Armada Gas Plant		
DH-LSD		Field	Red Deer District		
Jurisdiction #					
Serial #	808006.4B				
Ultrasonic Report #: 808006.4B_GRADY INSPECTION LTD VE UT INSP_31MAR2022

External Inspection - (Vessel)		Date	3/30/2022	Phone: 403-793-7697 8 Sarah King Crt E Brooks, Alberta, T1R 0J8 grady.rustebakke@gmail.com

LSD	01-18-017-18W4M	Facility	Armada Gas Plant		
DH-LSD		Field	Red Deer District		
Jurisdiction #

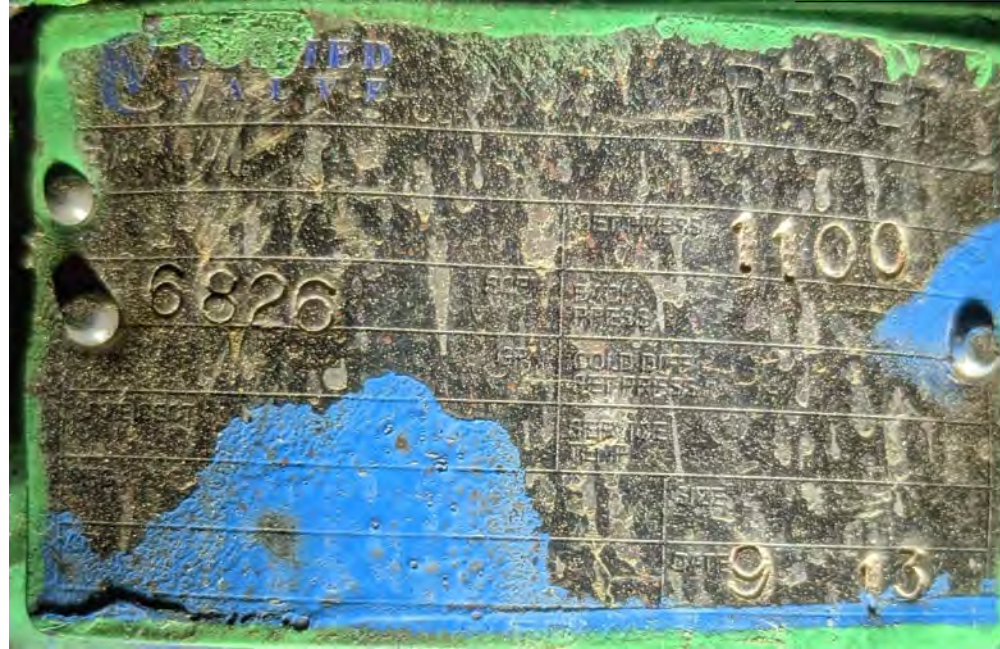
PSV Data

Not Fit For Service.

PSV COMMENTS

Broken Service Seal

Fit For Service:	Fit For Service.
Inspection Summary:	Vessel is in good visual condition. PSV service seal is broken
Recommendations:	Service PSV
