01-18-017-18W4M

FUEL GAS SCRUBBER #1

REPORT # FV-6-7-1006-2\_GRADY INSPECTION LTD VE UT INSP\_1APR2022

**GRADY**  
INSPECTION LTD

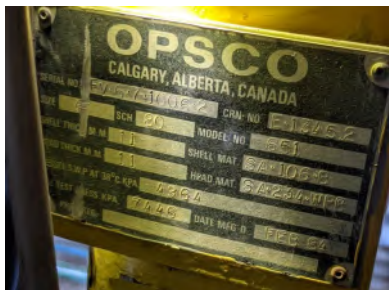
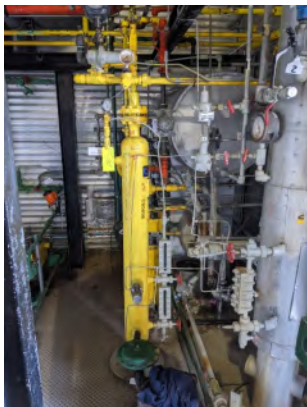
VE Inspection:  
Fit For Service. NCR. Check valve located on PSV discharge piping causing restriction.  
Vessel is not secured to foundation  
UT Inspection:  
No corrosion was found with the ultrasonic inspection.

VE Inspection:  
Remove check valve from PSV discharge piping  
Ensure vessel is secured to foundation

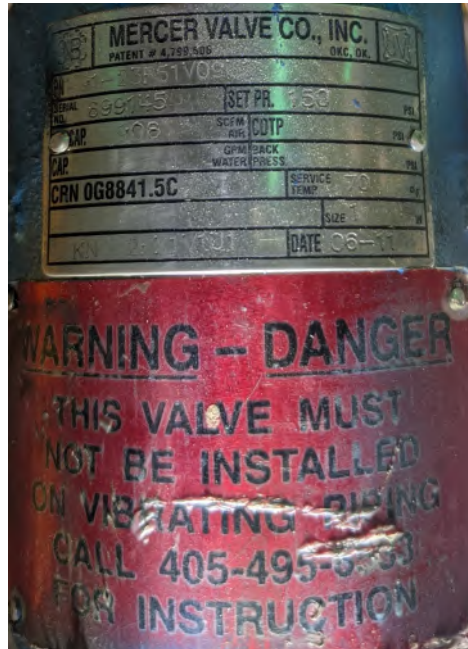
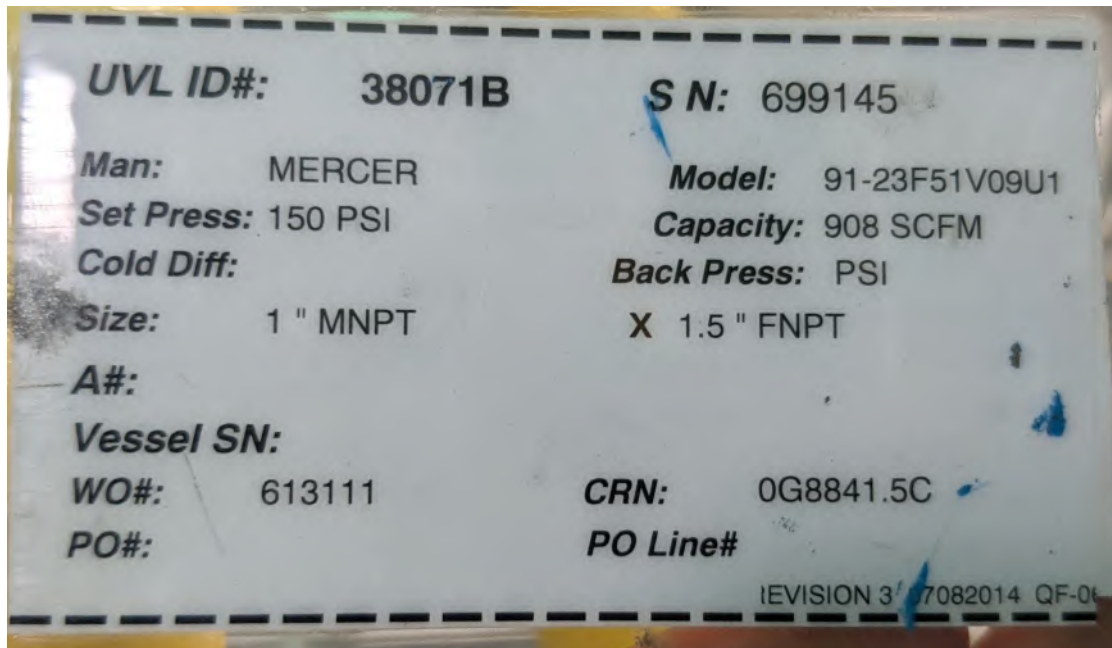
## PSV Data

<b>Pressure Protection:</b>		Poor	The PSV Set Pressure ( 150 psi) is suitable for the MAWP ( 720 psi) Check valve located on PSV discharge piping causing restriction.					
<b>NDE Summary:</b>		Good	No corrosion was found with the ultrasonic inspection.					
<b>Manway Davits/Quick Closure:</b>		N/A	No Manway					
<b>Nameplate:</b>		Good	Nameplate is legible and readily accessible and securely affixed

Not Fit For Service.

Check valve on PSV discharge piping. Located in Ajax / K101 compressor building.

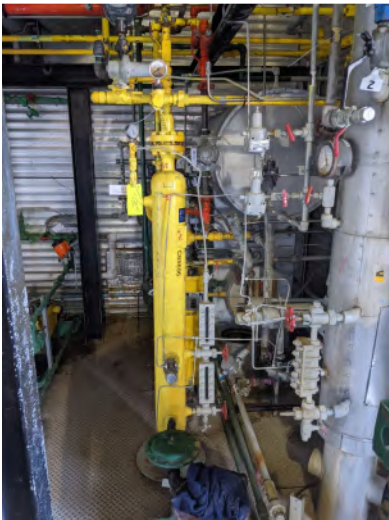
Overview

<b>LSD</b>	01-18-017-18W4M	<b>Facility</b>	Armada Gas Plant		8 Sarah King Crt E Brooks, Alberta, T1R 0J8			
<b>DH-LSD</b>		<b>Field</b>	Red Deer District		grady.rustebakke@gmail.com			
<b>Jurisdiction #</b>								
<hr/>								
<b>Fit For Service:</b>		Fit For Service.						
<hr/>								
<b>Inspection Summary:</b>		NCR. Check valve located on PSV discharge piping causing restriction. Vessel is not secured to foundation						
<hr/>								
<b>Recommendations:</b>		Remove check valve from PSV discharge piping Ensure vessel is secured to foundation						
<hr/>								
<b>External Inspection Items</b>		<b>G/F/P</b>	<b>Comments</b>					
<b>General Condition:</b>		Good	No notable mechanical damage, areas of wear/fretting, distortion, misalignment, or visible weld defects.					
<b>External Coating:</b>		Good	Vessel is in good visual condition. Vessel is painted. Vessel is indoors.

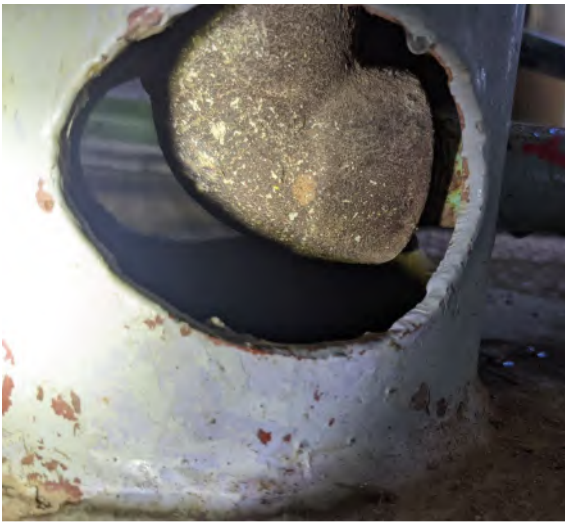
Drain Elbow

<b>Insulation / Cladding:</b>		N/A	Non insulated vessel					
<b>Nozzles, Piping and Connections:</b>		Good	Number of nozzles repaded: 0 Number of nozzles without repad: 2 Nozzles and piping in good visual condition No attached drain pipping					
<b>Buried Vessels:</b>		N/A	Above Ground					
<b>Ladders, Platforms and Walkways:</b>		N/A	No attached ladder or platform					
<b>Foundations and Supports:</b>		Fair	Building is secure on concrete pilings Vessel is not secured to foundation Concrete pilings are intact with no visible deficiencies					
<b>Shell:.</b>		Good	No notable mechanical damage, areas of wear/fretting, distortion, misalignment or visible weld defects.					
<b>Saddles / Skirts:</b>		Good	Skirt is in good visual condition.					
<b>Grounding:</b>		Good	Ground Wire is secure Grounded through piping system					
<b>Gauges and Instrumentation:</b>		Good	<div>Shell Gauge ( - @ )      Temp Gauge ( - @ )</div> Pressure gauge is not suitable for MAWP, is suitable for PSV set pressure.

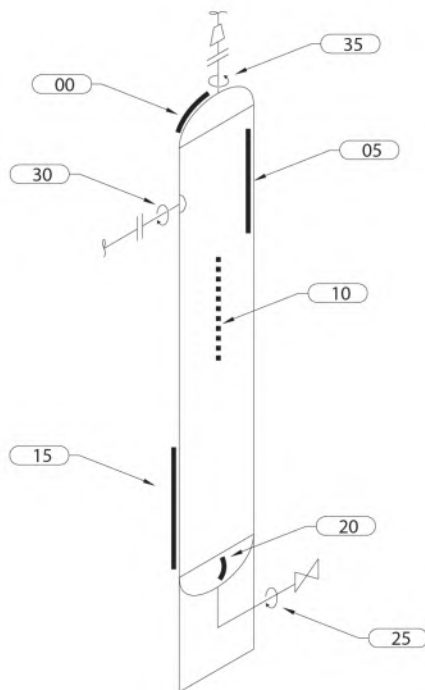
REPORT # FV-6-7-1006-2 GRADY INSPECTION LTD VE UT INSP\_1APR2022  
LSD 01-18-017-18W4M FACILITY Armada Gas Plant  
DH-LSD FIELD Red Deer District  
Jur # DWG 1 Location:  
Ser # FV-6-7-1006-2
