01-18-017-18W4M
FUEL GAS SEPARATOR
1007.186C87832
REPORT # 1007.186_GRADY INSPECTION LTD VE UT INSP_1APR2022

DATE 4/1/2022
CLIENT CNRL

PRESSURE EQUIPMENT										AB-506 INTERVAL																																													
DISTRICT					SHELL					TUBE					Fuel gas scrubbers																																								
FACILITY					ARMADA					MAWT					100					F																																			
A#					YR					2000					MAWP					150					psi																														
SERIAL #					1007.186					PSV					150					psi					INSPECTION TYPE																														
CRN					0H2298.2134					PSV CRN					0G2606.5C																																								
EQUIP#					SERVICED					3/1/2016																																													
STATUS					IN SERVICE					UNIT					Refridge COMP					VE						VI						MT						PT						ET						UT					
MANUFACTURER					Lo Tech					INSPECTION RESULT:																																													
DH LSD					L					2.2 Ft					OD					.72 Ft					NCR-OPERATIONS																														
REPAD					0					UNIQUE ID					C87832					NCR-REGULATORY/ADMIN

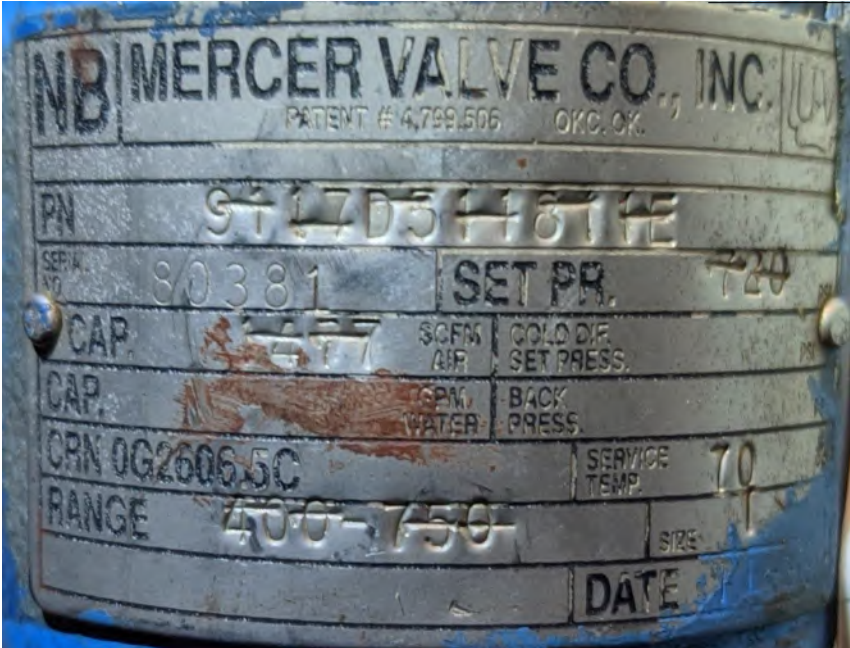
PSV Data
LSD

ASSOCIATED PRESSURE EQUIPMENT DATA			
PV JUR/SER		1007.186	
		SHELL	TUBE
MAWP	150		psi
PSV FIT FOR SERVICE STATEMENT			
Fit For Service.			
PSV STATIC DATA			
MODEL	9117D511807E		
SERIAL	80381		
MANUFACTURER	MERCER		
TAG	38060B		
CRN	0G2606.5C		
SEAL	Y		
SET PRES	150		psi
CAPACITY	329		SCFM
SERVICE DATE	3/1/2016		
SERVICE COMPANY	Unifed Valve		
		T/F	UV NB
		T	U NB
		SIZE	B VALVE CARSEAL
INLET	1	N	
OUTLET	1	N	
PSV COMMENTS

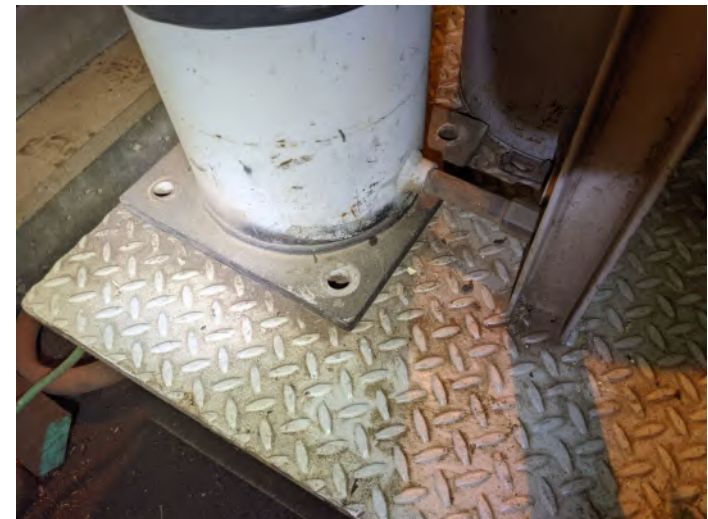
VE Inspection:
Fit For Service. Vessel not secured to foundation
No weep hole in PSV discharge elbow
UT Inspection:
No corrosion was found with the ultrasonic inspection.

**No securement**

ACTION ITEM RAISED												X																																	
										REPAIR REQUIRED																																													
										SUITABLE FOR SERVICE												X																																	
										RECOMMENDATIONS:																																													
										VE Inspection: Ensure vessel is secured to foundation Install weep hole to prevent fluid accumulation in PSV discharge piping

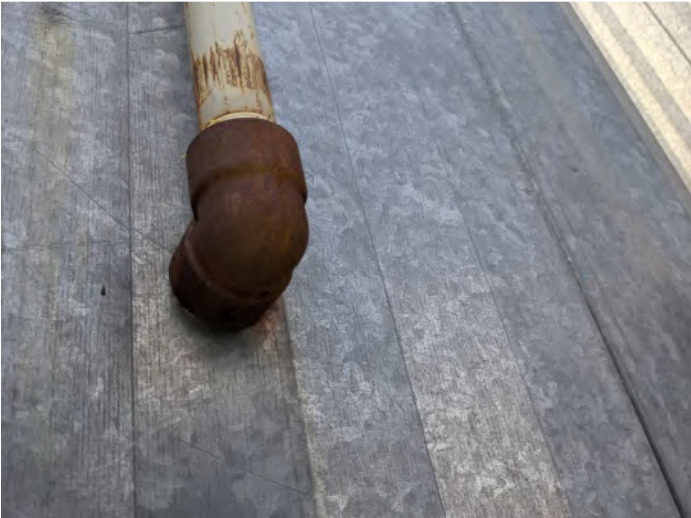
Gauges and Instrumentation:	N/A	Shell Gauge (- @) Temp Gauge (- @) No gauges found.
Pressure Protection:	Fair	PSV set pressure of 150 psi is suitable for vessel MAWP of 150psi PSV discharge piping has a upward vertical rise creating a fluid trap.
NDE Summary:	Good	No corrosion was found with the ultrasonic inspection.
Manway Davits/Quick Closure:	N/A	No Manway.
Nameplate:	Good	Nameplate is legible and readily accessible and securely affixed
Code Variance:

PSV discharge elbow
