01-18-017-18W4M  
GLYCOL CHARCOAL FILTER  
A0225255 85-0687-2  
REPORT # A#0225255\_GRADY INSPECTION LTD VE UT INSP\_1APR2022

DATE 4/1/2022  
CLIENT CNRL

VE Inspection:  
Fit For Service. Vessel is in good visual condition.  
UT Inspection:  
No corrosion was found with the ultrasonic inspection.

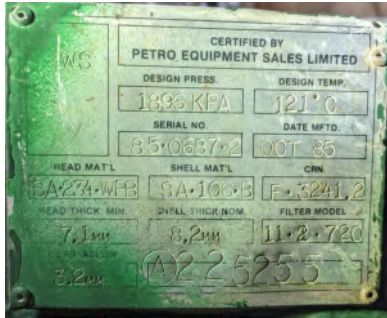
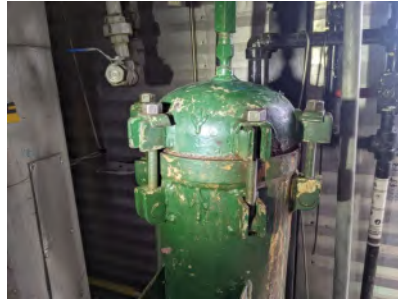
<b>Fit For Service:</b>	Fit For Service.
<b>Inspection Summary:</b>	Vessel is in good visual condition.
<b>Recommendations:</b>	Recommend installing gauges suitable for design parameters

VE Inspection: Recommend installing gauges suitable for design parameters

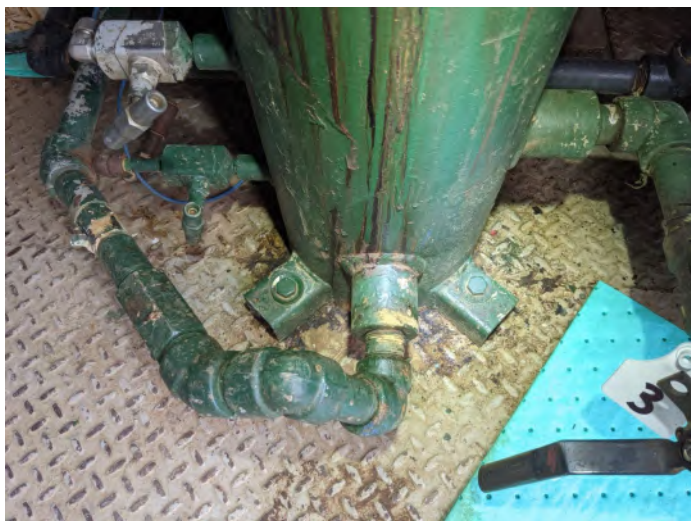
Vessel support

External Inspection Items	G/F/P	Comments
General Condition:	Good	No notable mechanical damage, areas of wear/fretting, distortion, misalignment, or visible weld defects.
External Coating:	Good	Vessel is in good visual condition. Paint is intact and well adhered to the vessel. Vessel is indoors.
Insulation / Cladding:	N/A	Non insulated vessel
Nozzles, Piping and Connections:	Good	Number of nozzles repaded: 0 Number of nozzles without repad: 0 Nozzles and piping in good visual condition
Buried Vessels:	N/A	Above Ground
Ladders, Platforms and Walkways:	N/A	No attached ladder or platform
Foundations and Supports:	Good	Building is secure Building on concrete pilings
Shell:.	Good	No notable mechanical damage, areas of wear/fretting, distortion, misalignment or visible weld defects.
Saddles / Skirts:	Good	Saddle is in good visual condition
Grounding:	Good	Ground Wire is secure Grounded through piping system
