01-18-017-18W4M
CONDENSATE STABILIZER TOWER
A0205694 84C-3203-05
REPORT # A#0205694_GRADY INSPECTION LTD VE UT INSP_2MAY2022

DATE 5/2/2022
CLIENT CNRL

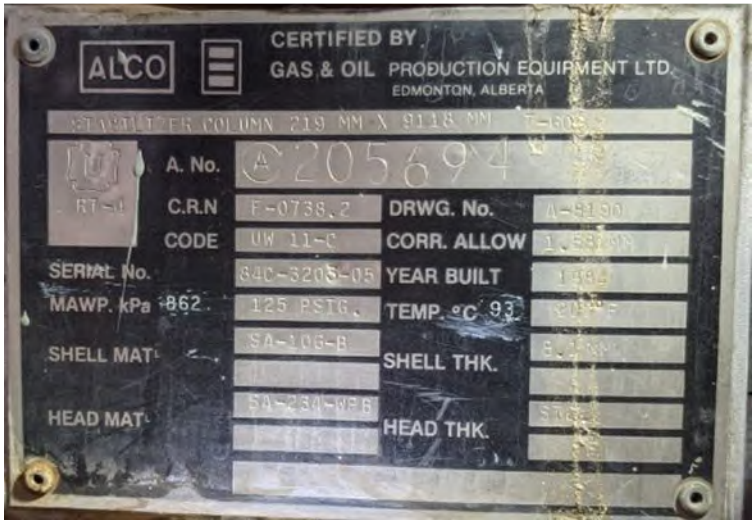
Pressure Protection:	N/A	Out for service at time of inspection
NDE Summary:	Good	No corrosion was found with the ultrasonic inspection.
Manway Davits/Quick Closure:	N/A	No Manway
Nameplate:	Good	Nameplate is legible and readily accessible and securely affixed
Code Variance:

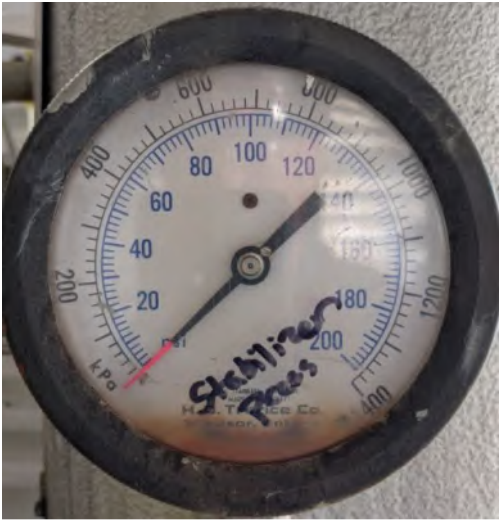
Pressure Gauge

External Inspection Items	G/F/P	Comments
General Condition:	Good	No notable mechanical damage, areas of wear/fretting, distortion, misalignment, or visible weld defects.
External Coating:	Good	Vessel is in good visual condition. non measurable corrosion found visually.
Insulation / Cladding:	Fair	Insulation is in good visual condition. Staining identified.
Nozzles, Piping and Connections:	Good	Nozzles and piping in good visual condition
Buried Vessels:	N/A	Above Ground
Ladders, Platforms and Walkways:	Good	Building secure
Foundations and Supports:	Good	Anchor bolts fully engaged
Shell:.	Good	No notable mechanical damage, areas of wear/fretting, distortion, misalignment or visible weld defects.
Saddles / Skirts:	Good	Skirt is in good visual condition
Grounding:	Good	Ground Wire is secure
Gauges and Instrumentation:	Good	<div>Shell Gauge (0 - 200 @ psi)</div> <div>Temp Gauge (50 - 500 @ F)</div> <div>Gauges are clear, colorless and correct for the MAWP and MAWT.</div>

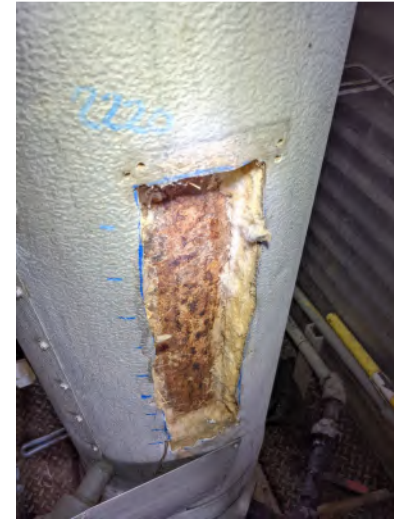
**Non-measurable corrosion at CML Port**

Fit For Service:	Fit For Service.
Inspection Summary:	Vessel is in good visual condition.
Recommendations:	Inspect PSV after installation to confirm suitability. Visually monitor for CUI
