01-18-017-18W4M
PROPANE DEOILER
A2648336 516-V111
REPORT # A#2648336_GRADY INSPECTION LTD VE UT INSP_2MAY2022

DATE 5/2/2022
CLIENT CNRL

External Inspection - (Vessel)		Date	3/30/2022	Phone: 403-793-7697 PO Box 1173, Brooks, Alberta, T1R 19B grady.rustebakke@gmail.com

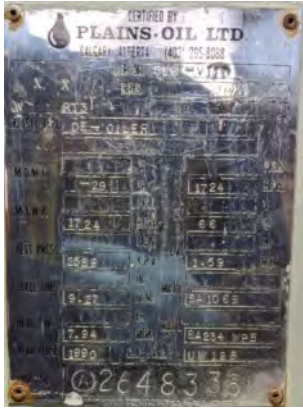
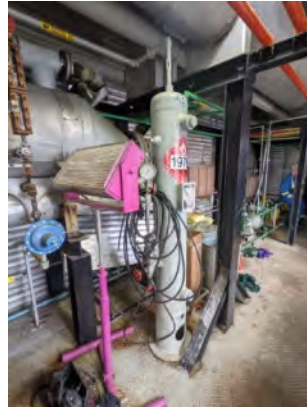
VE Inspection:
Fit For Service. Vessel is in good visual condition.
UT Inspection:
No corrosion was found with the ultrasonic inspection.

PRESSURE EQUIPMENT										AB-506 INTERVAL					
DISTRICT	AB - OIL & NATURAL GAS				SHELL		TUBE		Refrigeration Vessels						
FACILITY	Armada Gas Plant				MAWT	151		F	GRADE		YEARS			REG	
A#	A2648336		YR	1990	MAWP	375		psi			Equip	PSV	UT		
SERIAL #				PSV				psi	3		10	5	10	X	
CRN	E-5491.2			PSV CRN											
EQUIP#				SERVICED											
STATUS	OUT OF SERVICE				UNIT	Refridge				INSPECTION TYPE					
										VE	VI	MT	PT	ET	UT
										X					X
MANUFACTURER	PLAINS OIL LTD.									INSPECTION RESULT:					
DH LSD					L	Ft		OD	Ft		NCR-OPERATIONS				
REPAD	UNIQUE ID									NCR-REGULATORY/ADMIN					
										ACTION ITEM RAISED					
										REPAIR REQUIRED					
										SUITABLE FOR SERVICE				X	
										RECOMMENDATIONS:					
										VE Inspection: Install temperature gauge. Inspect PSVs after installation

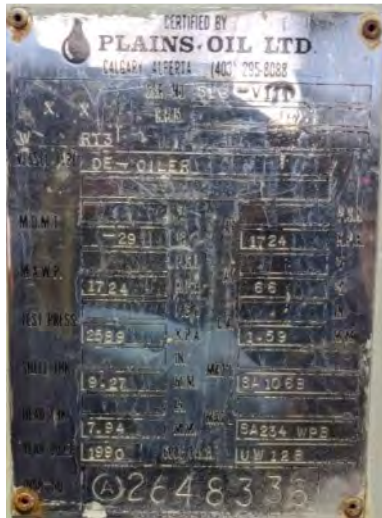
Pressure Protection:	N/A	Out for service at time of inspection
NDE Summary:	Good	No corrosion was found with the ultrasonic inspection.
Manway Davits/Quick Closure:	N/A	No Manway
Nameplate:	Good	Nameplate is legible and readily accessible and securely affixed
Code Variance:

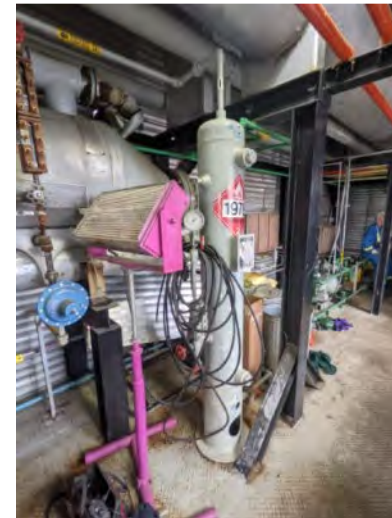
Overview

External Inspection Items	G/F/P	Comments
General Condition:	Good	No notable mechanical damage, areas of wear/fretting, distortion, misalignment, or visible weld defects.
External Coating:	Good	Vessel is in good visual condition. Painted with approximately 10-15% flaking paint. Under coat is in good condition.
Insulation / Cladding:	N/A	Non insulated vessel
Nozzles, Piping and Connections:	Good	Nozzles and piping in good visual condition
Buried Vessels:	N/A	Above Ground
Ladders, Platforms and Walkways:	Good	Building secure
Foundations and Supports:	Good	Welds secure
Shell:.	Good	No notable mechanical damage, areas of wear/fretting, distortion, misalignment or visible weld defects.
Saddles / Skirts:	Good	Skirt is in good visual condition
Grounding:	Good	Ground Wire is secure
Gauges and Instrumentation:	Fair	<div>Shell Gauge (0 - 500 @ psi) Temp Gauge (- @)</div> <div>Pressure gauge needle is broken. Gauge is clear, colorless and correct for the MAWP. No temperature gauge found</div>

Fit For Service:	Fit For Service.
Inspection Summary:	Vessel is in good visual condition.
Recommendations:	Install temperature gauge. Inspect PSVs after installation
