Ultrasonic Report		Date	4/1/2022	Phone: 403-793-7697 8 Sarah King Crt E Brooks, Alberta, T1R 0J8 grady.rustebakke@gmail.com	
LSD	01-18-017-18W4M	Facility	Armada Gas Plant		
DH-LSD		Field	Red Deer District		
Jurisdiction #					
Serial #	808006.2B				
Ultrasonic Report #: 808006.2B_GRADY INSPECTION LTD VE UT INSP_31MAR2022

External Inspection - (Vessel)		Date	4/1/2022	Phone:403-793-7697

Overview Photo

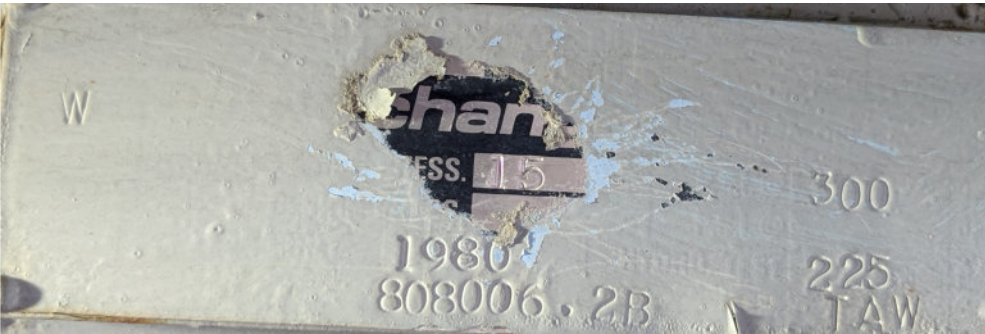
Manway Davits/Quick Closure:	N/A	No Manway
Nameplate:	Fair	Nameplate is painted over. 15 psi MAWP is visible, vessel is non-code
Code Variance:

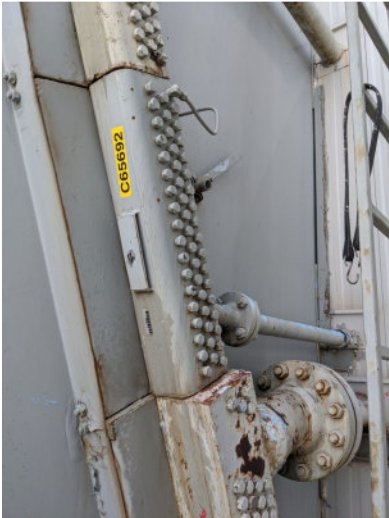
Overview

Fit For Service:	Fit For Service.
Inspection Summary:	Vessel is in good visual condition.
Recommendations:	No Recommendations from the External Inspection.
